### **Photographic Schedule**

# High Borrans Activity Centre Photographic Schedule

Windermere, Cumbria, LA23 1JS

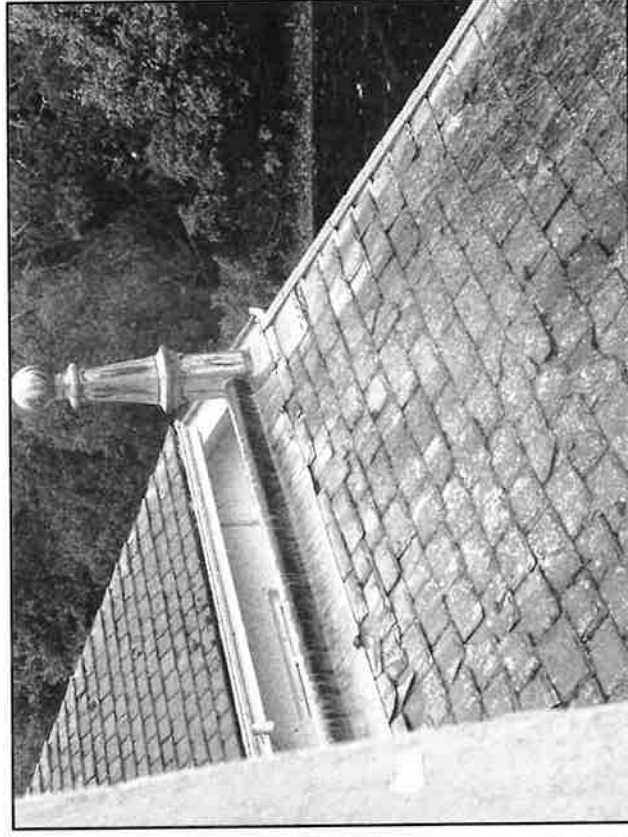
002. Example of damaged slate tiles to roof coverings

| High Bursar Activity Centre - Condition Survey Budget Costs | | | | | | | | |
|---|---|---|---|---|---|---|---|---|
| 2.24 | | Isolated instances of missing, missing or cracked slate roof tiles to main elevations | Remove broken and slipped tiles and replace to match existing | £ | 0 | £ | 10,640.00 | £ |

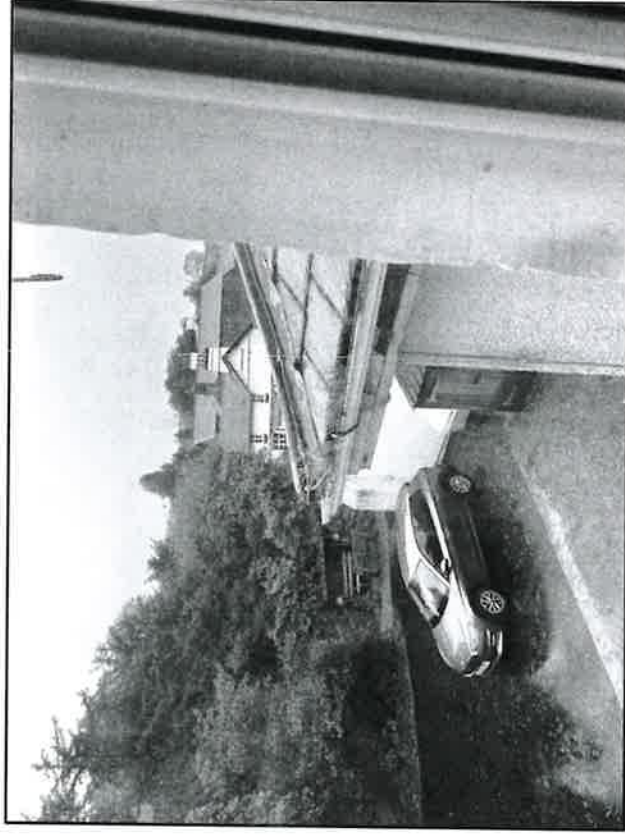
003. Example of vegetation to gutters

| High Bursar Activity Centre - Condition Survey Budget Costs | | | | | | | | |
|---|---|---|---|---|---|---|---|---|
| 2.22 | | Several instances of vegetation growth noted to gutters, approx 50m to be cleared | Clear gutters of any vegetation and/or debris and leave clear and free flowing | £ | 0 | £ | 1,550.00 | £ |

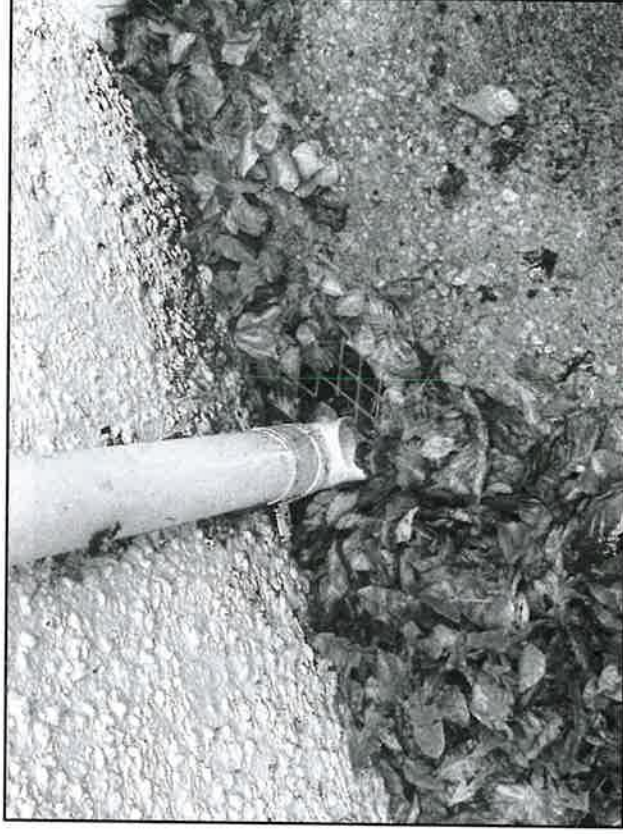
004. Example of gutleys filled with fallen leaves

| High Bursar Activity Centre - Condition Survey Budget Costs | | | | | | | | |
|---|---|---|---|---|---|---|---|---|
| 2.23 | | Number of gulleys noted to be filled with fallen leaves | Remove vegetation and install leaf guard to all gulleys | £ | 0 | £ | 240.00 | £ |

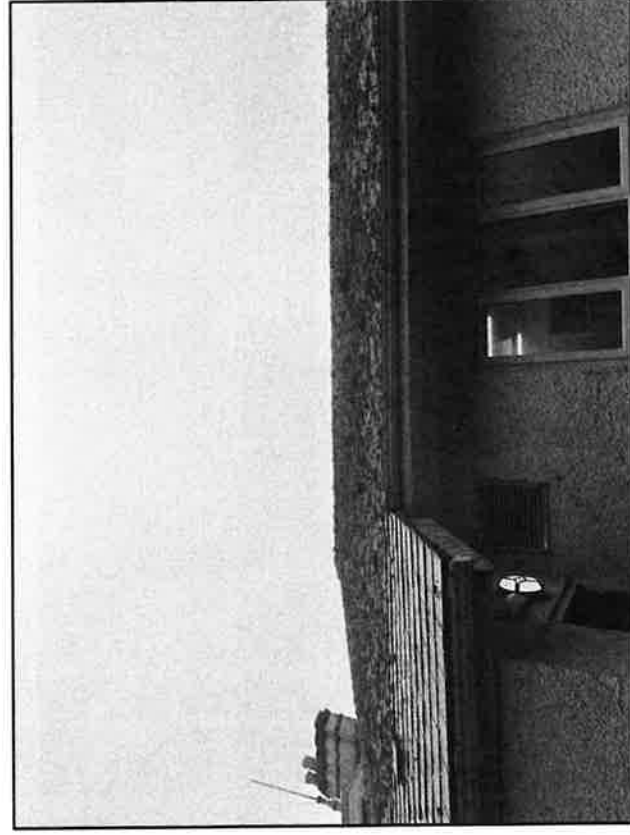
005. Example of moss growth to slate roof covering

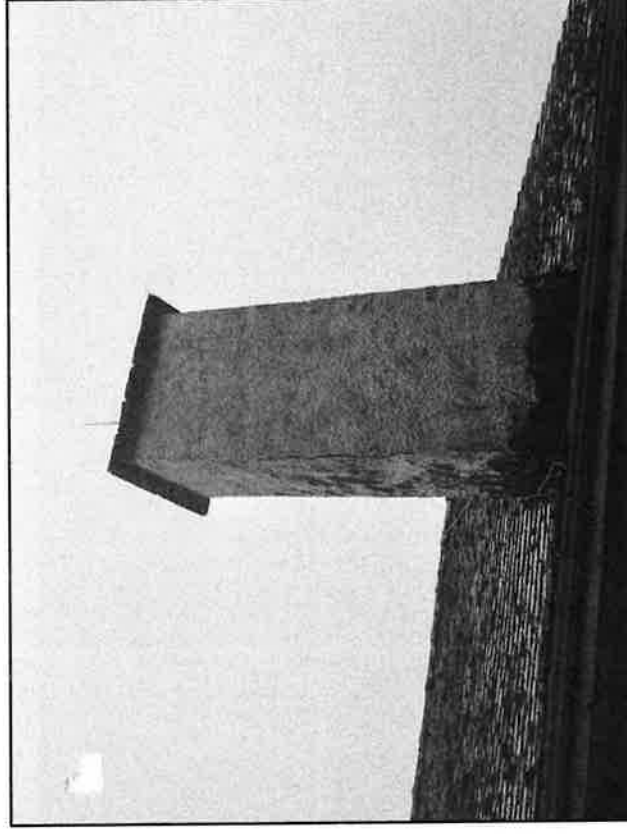
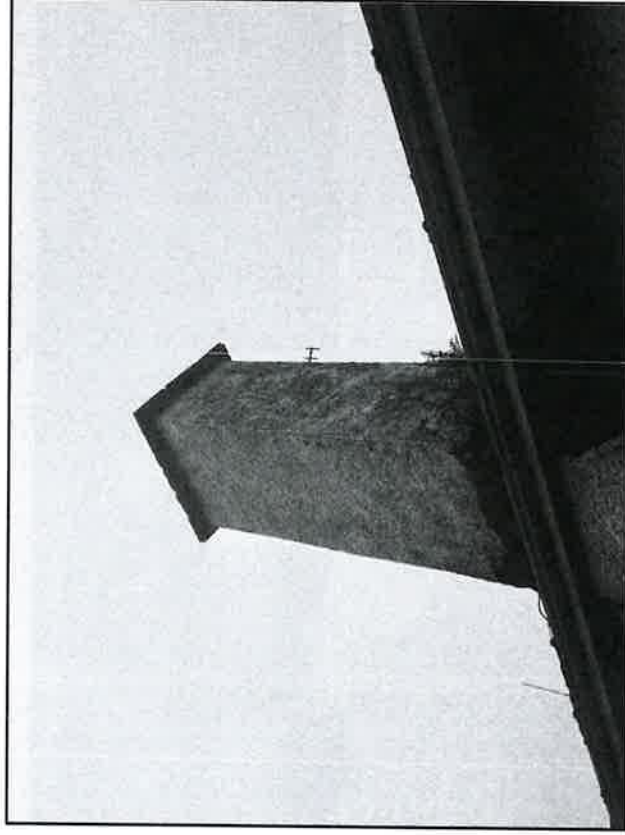
006. Crack to render finished chimney above dining room

007. Crack to render finished chimney above dining room and vegetation growth at base of stack

| High Bursar Activity Centre - Condition Survey Budget Costs | | | | | | | | |
|---|---|---|---|---|---|---|---|---|
| 2.2 | | 1N vertical cracks approx. 5mm wide with slight displacement of render finish to chimney at RHS main elevation | Hack away render finish and inspect integrity of chimney. Undertake repairs as necessary and then re-apply render finish to match existing | £ | 600.00 | £ | 0 | £ |

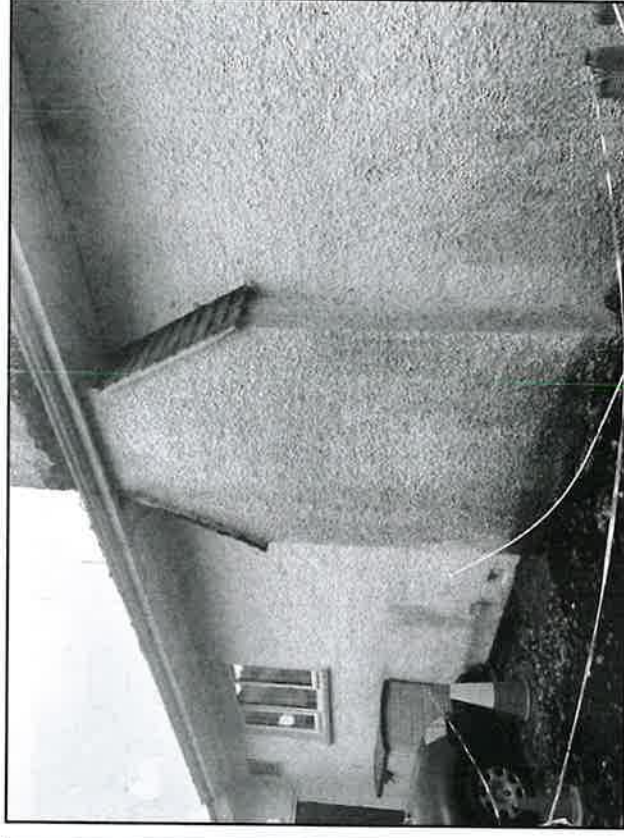
008. Example of algae growth to render finish

| High Bursar Activity Centre - Condition Survey Budget Costs | | | | | | | | |
|---|---|---|---|---|---|---|---|---|
| 2.6 | | Staining, algae and moss growth in render finish to isolated section throughout | Remove moss with soft brush, clean algae with suitable biocide and re-render to match existing | £ | 0 | £ | 1,700.00 | £ |

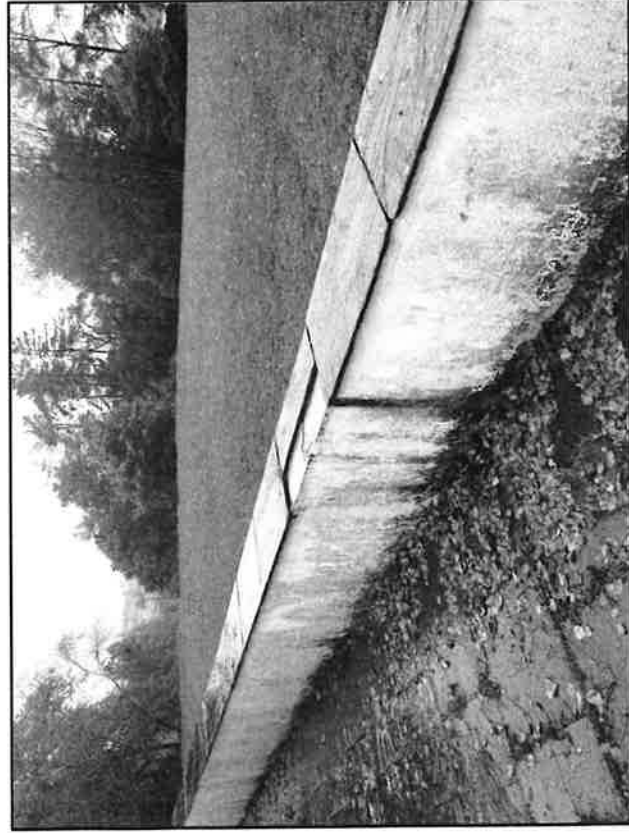
| | Finding | Recommendation | Photo |
|--|---|---|---|
| | Missing coping stone to boundary wall to RHS elevation | Supply and install stone to match existing | 009 |

009. Example of missing coping stone to boundary wall

| High Bursar Activity Centre - Condition Survey Budget Costs | | | | | | | | |
|---|---|---|---|---|---|---|---|---|
| 2.19 | | Missing coping stone to boundary wall to RHS elevation | Supply and install stone to match existing | £ | 0 | £ | 50.00 | £ |

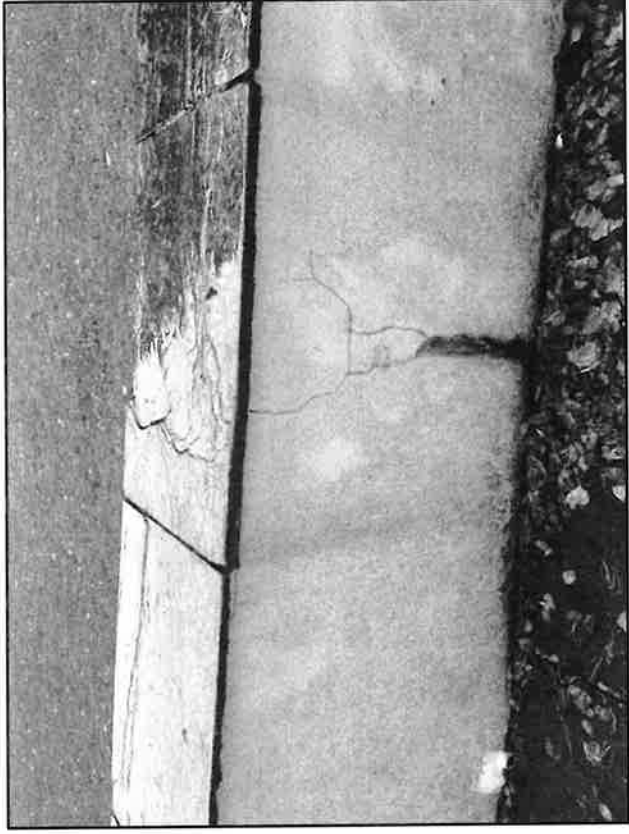
| | Finding | Recommendation | Photo |
|--|---|---|---|
| | Few instances of cracking to render finished boundary wall to RHS elevation | Repair damaged rendering - hack off and renew to match existing | 010 |

010. Example of cracking render finish to boundary wall

| High Bursar Activity Centre - Condition Survey Budget Costs | | | | | | | | |
|---|---|---|---|---|---|---|---|---|
| 2.20 | | Few instances of cracking to render finish on boundary wall to RHS elevation | Repair damaged rendering - hack off and renew to match existing | £ | 0 | £ | 400.00 | £ |

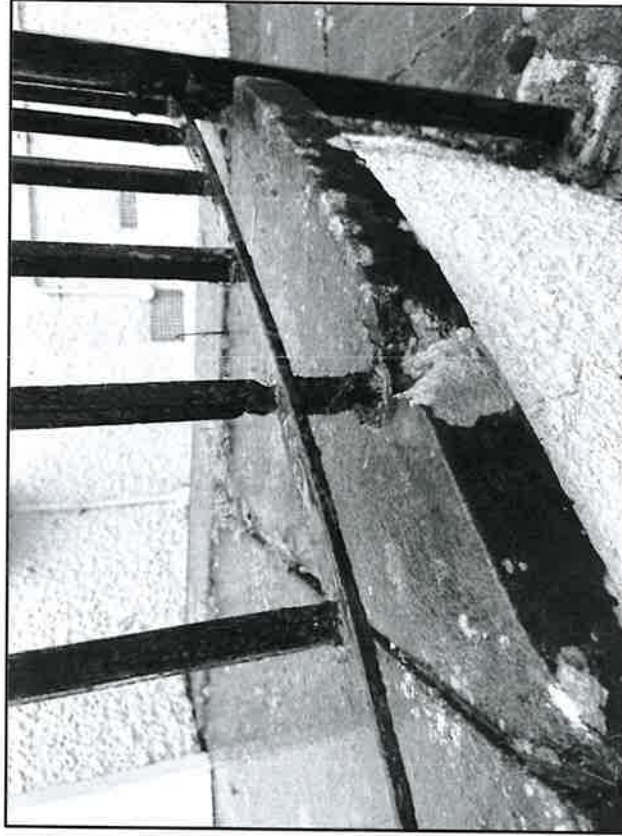
| | Finding | Recommendation | Photo |
|--|---|---|---|
| | Volume loss to few iron rail spindles adjacent to dining hall | Remove and replace | 011 |

011. Volume loss to few iron fence spindles to dining hall

| High Bursar Activity Centre - Condition Survey Budget Costs | | | | | | | | |
|---|---|---|---|---|---|---|---|---|
| 2.18 | | Volume loss to low iron rail spindles adjacent to orangery | Remove and replace | £ | 0 | £ | 1,000.00 | £ |

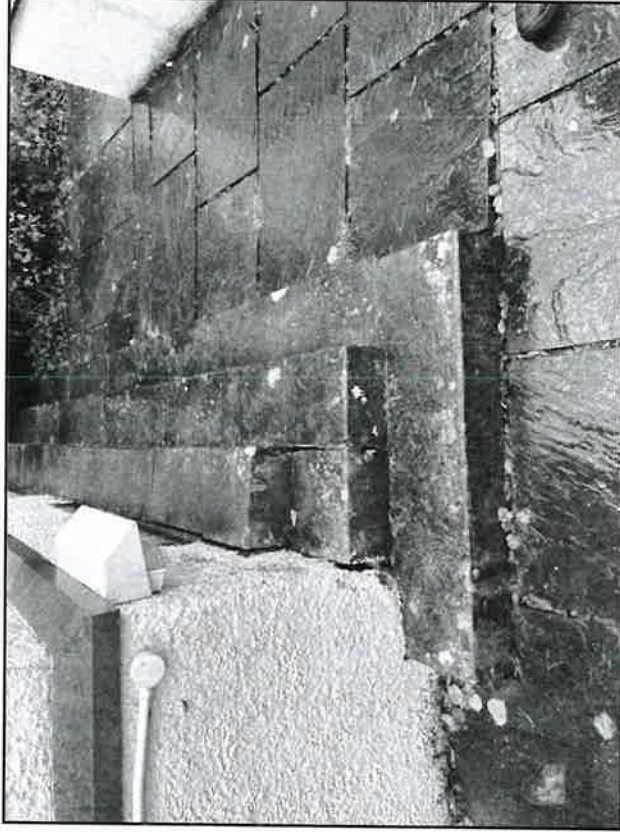
| | Finding | Recommendation | Photo |
|--|---|---|---|
| | Stone steps appear to be out of plumb and leaning away from the building adjacent to orangery | Take up existing, prepare base, lay new stone | 012 |

012. Stone steps appear to be out of plumb and leaning away from the building adjacent to orangery

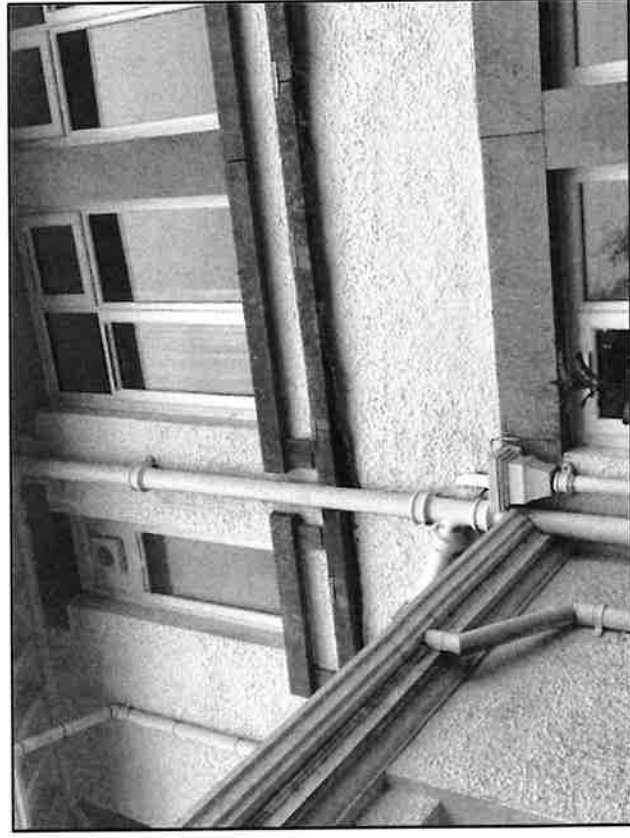
013. Lead waterproofing detail to stonework is loose

| High Bursar Activity Centre - Condition Survey Budget Costs | | | | | | | | |
|---|---|---|---|---|---|---|---|---|
| 2.16 | | Stone work at FF level has lost waterproofing detail which is loose in places | Re-apply existing flashing, approx 17m | £ | 0 | £ | 750.00 | £ |

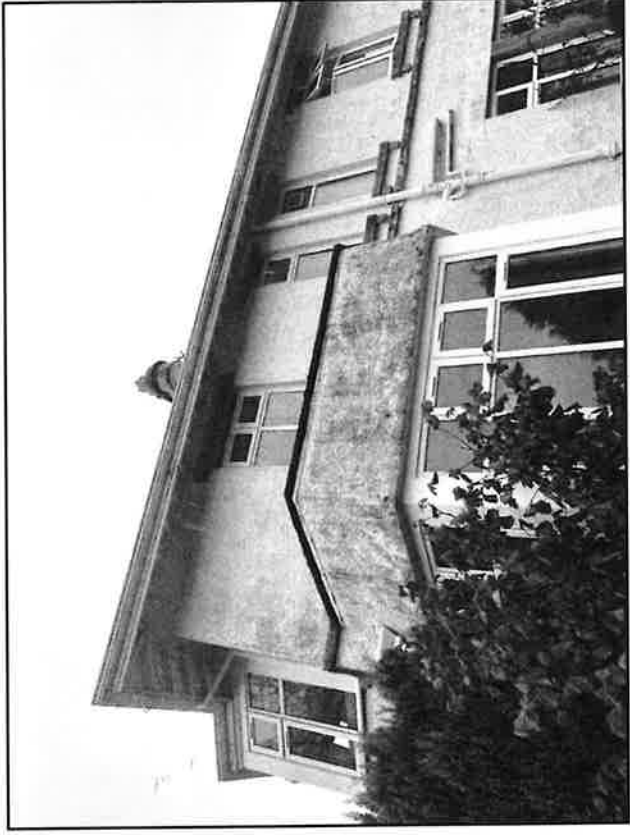
014. Staining and moss growth to render above lounge bay window

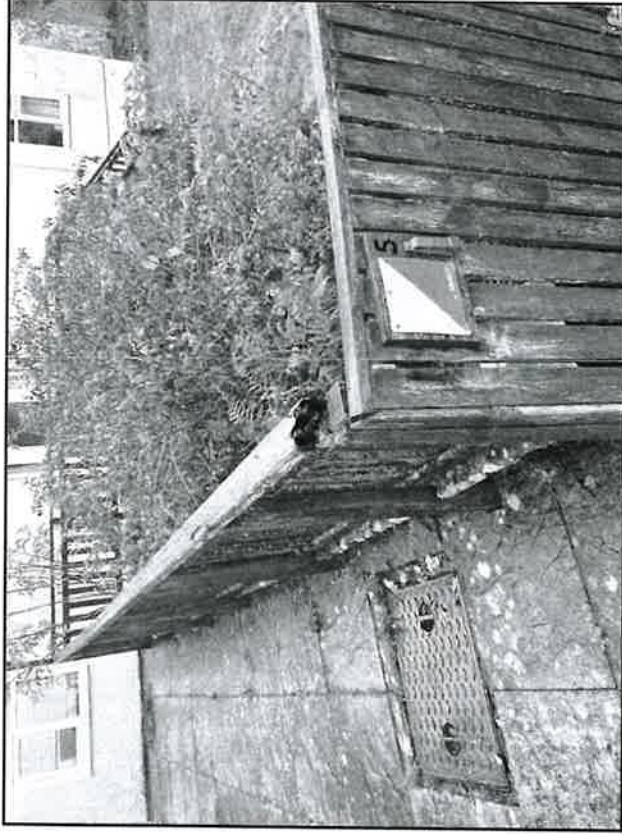
| | Finding | Recommendation | Photo |
|--|---|---|---|
| | Volume loss to section of timber handrail due to rot at rear elevation | | 015 |

015. Volume loss of timber handrail due to rot at rear elevation

| High Bursar Activity Centre - Condition Survey Budget Costs | | | | | | | | |
|---|---|---|---|---|---|---|---|---|
| 2.15 | | Volume loss to section of timber handrail due to rot at rear elevation | Remove and replace | £ | 0 | £ | 100.00 | £ |

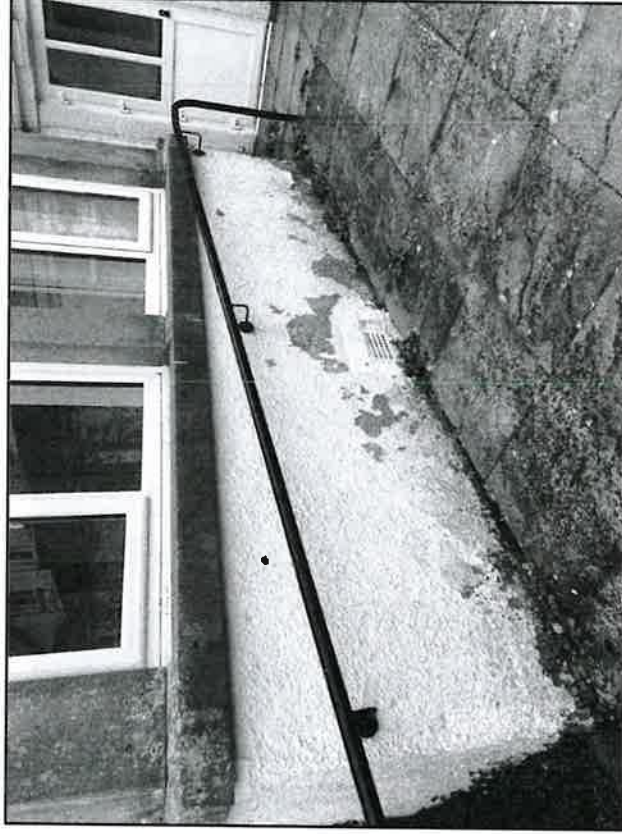
016. Example of flaking paint finish to render at rear elevation

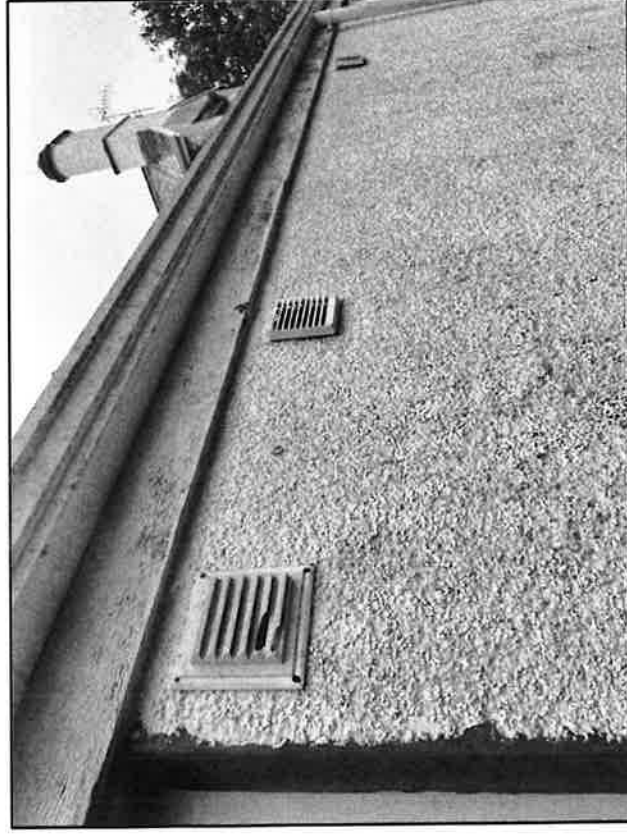
017. Painted timber fascia at rear elevation in poor condition

| High Bursar Activity Centre - Condition Survey Budget Costs | | | | | | | | |
|---|---|---|---|---|---|---|---|---|
| 2.7 | | Painted timber fascias, soffits and barge boards are in poor decorative condition throughout across all elevations | Take down existing soffits and fascias, replace with new, including decoration | £ | 0 | £ | 24,650.00 | £ |

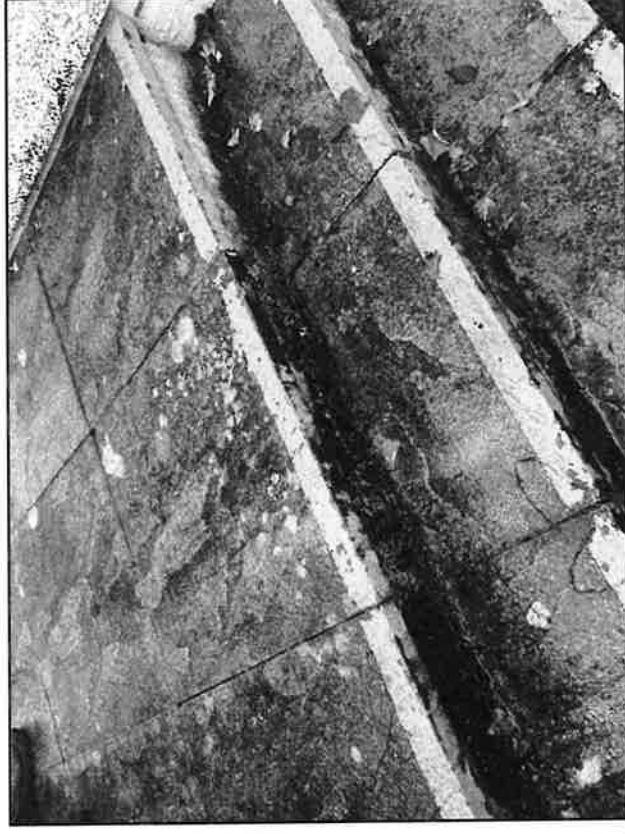
| | Finding | Recommendation | Photo |
|--|---|---|---|
| | Several instances of paving slabs being loose/displaced underfoot, potential trip hazard | Take up loose pavers, prepare base and re-lay existing | 018 |

018. Example of paving slabs lifting / loose underfoot

| High Bursar Activity Centre - Condition Survey Budget Costs | | | | | | | | |
|---|---|---|---|---|---|---|---|---|
| 2.3 | | Several instances of paving slabs being loose/displaced underfoot, potential trip hazard | Take up loose pavers, prepare base and lay existing | £ | 1,200.00 | £ | 0 | £ |

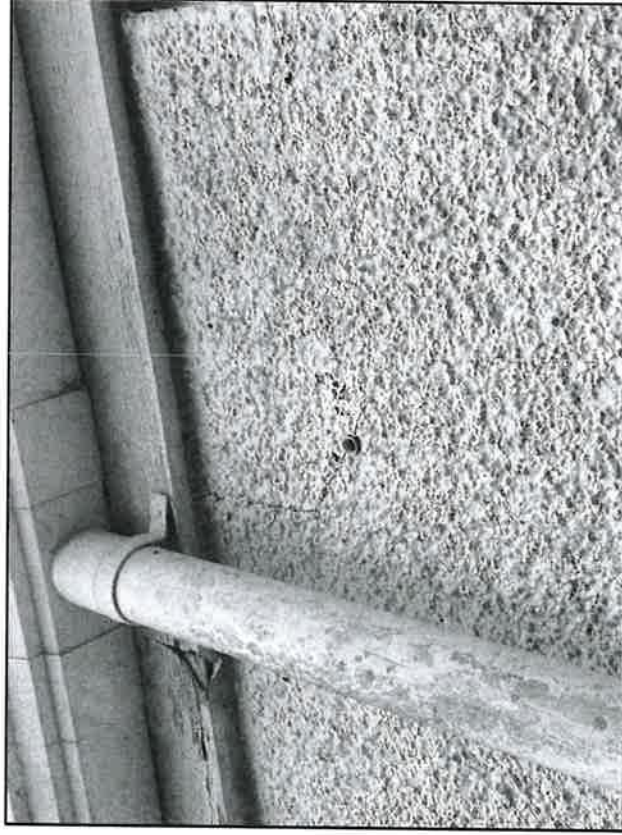
019. Crack to render at rear elevation of one storey bedroom section

| High Bursar Activity Centre - Condition Survey Budget Costs | | | | | | | | |
|---|---|---|---|---|---|---|---|---|
| 2.9 | | Isolated areas of render in poor condition, cracking and flaking | Repair damaged rendering - hack off and renew to match existing | £ | 0 | £ | 1,400.00 | £ |

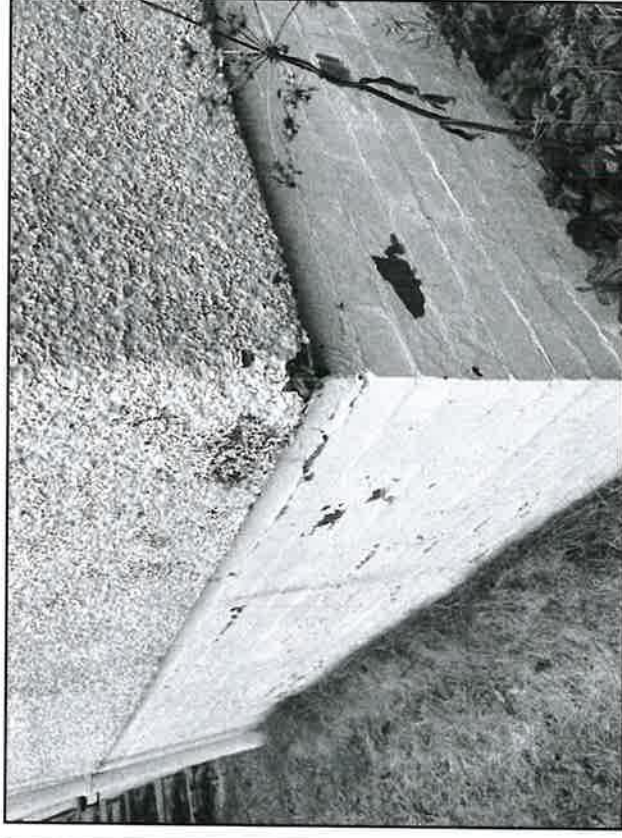
020. Damage to corner of render at rear elevation of one storey bedroom section

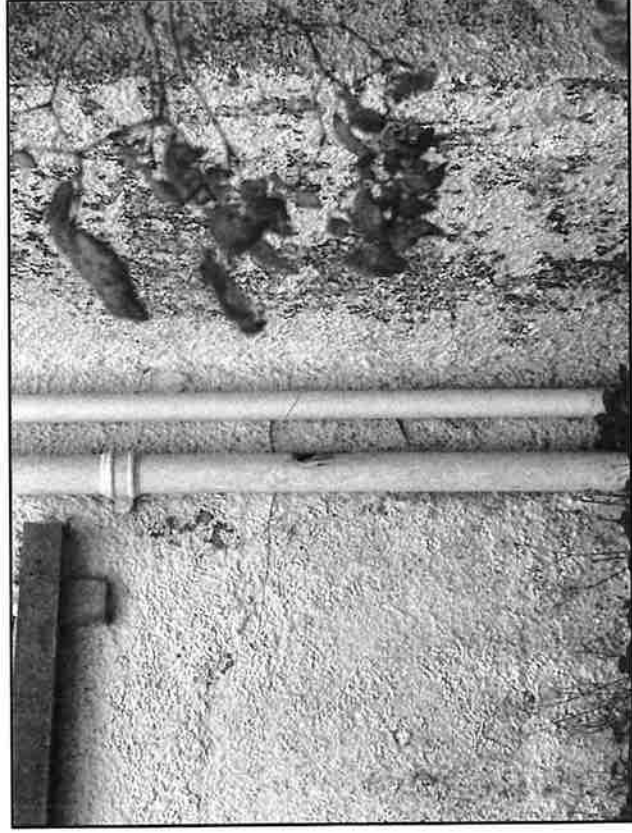
021. Hole due to corrosion to cast iron down pipe at rear elevation adjacent to equipment store

| High Bursar Activity Centre - Condition Survey Budget Costs | | | | | | | | |
|---|---|---|---|---|---|---|---|---|
| 2.14 | | Gate to cast iron downpipe due to corrosion at rear elevation adjacent to equipment store | Remove and replace with PVCu downpipe | £ | 0 | £ | 215.00 | £ |

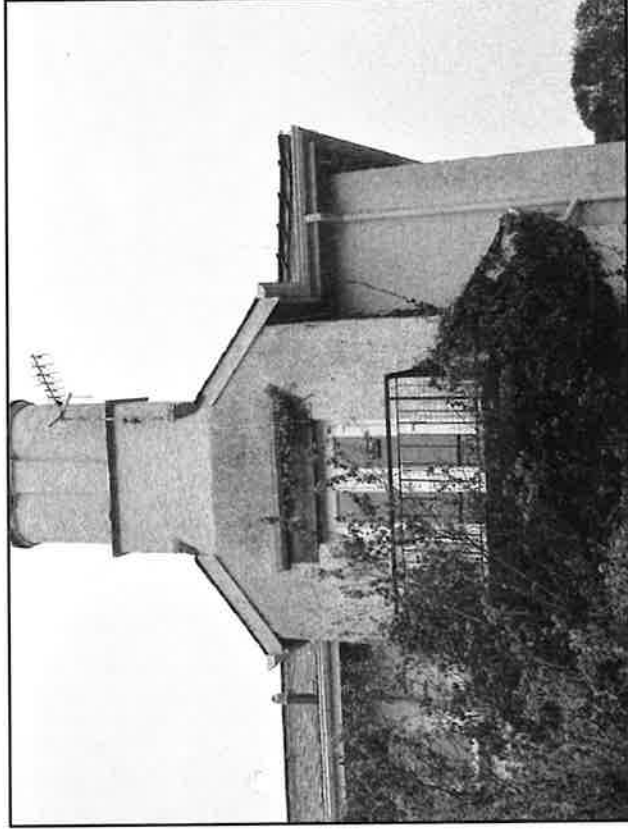
022. Vegetation growth above stone lintel of F18 lounge

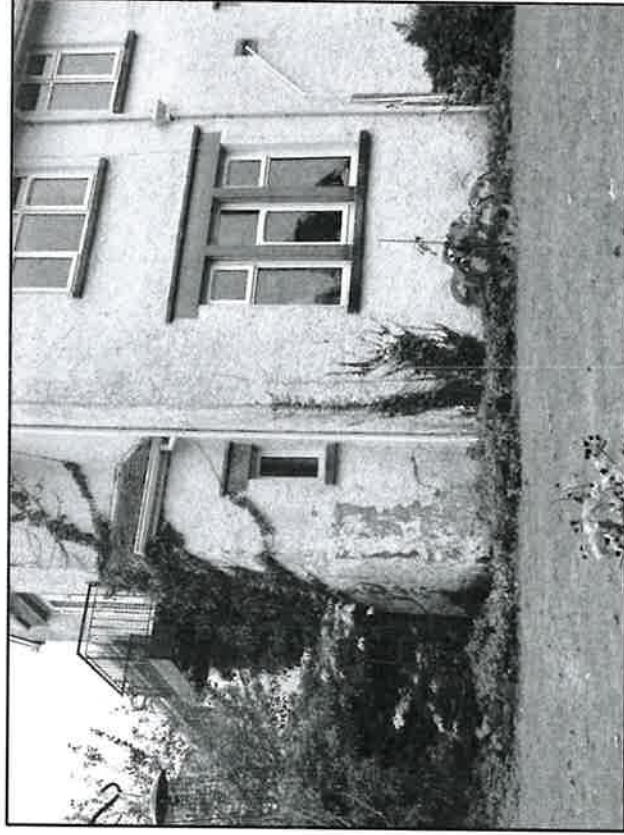
023. Ivy growth to render finished walls at rear and left hand side elevation

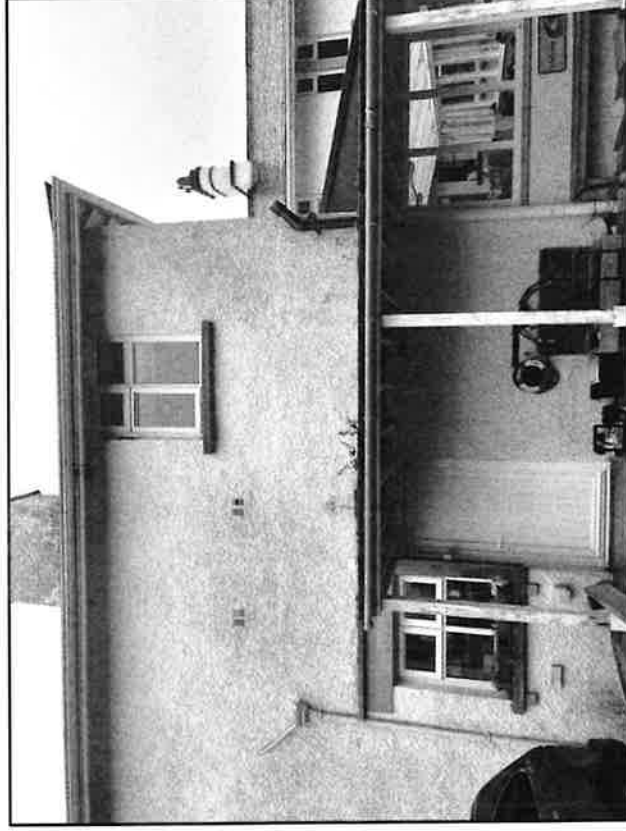
025. Vegetation growth to timber canopy at LHS of front elevation

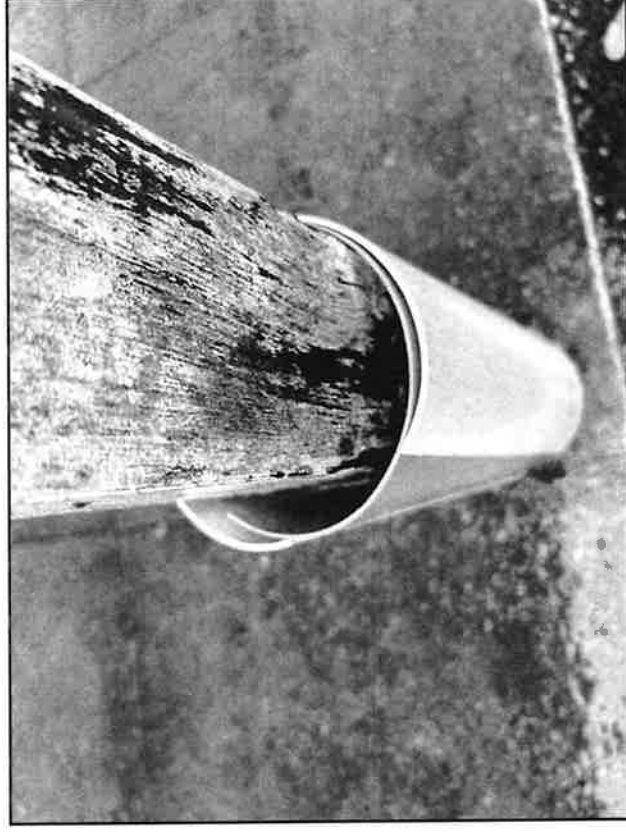
| | Finding | Recommendation | Photo |
|--|---|---|---|
| | 3Nr timber posts to canopy at front elevation showing signs of rot at the base | Remove and replace | 026 |

026. Timber posts to canopy are showing signs of rot at the base

| High Bursar Activity Centre - Condition Survey Budget Costs | | | | | | | | |
|---|---|---|---|---|---|---|---|---|
| 2.12 | | 1N timber posts to canopy at front elevation showing signs of rot at the base | Remove and replace | £ | 0 | £ | 300.00 | £ |

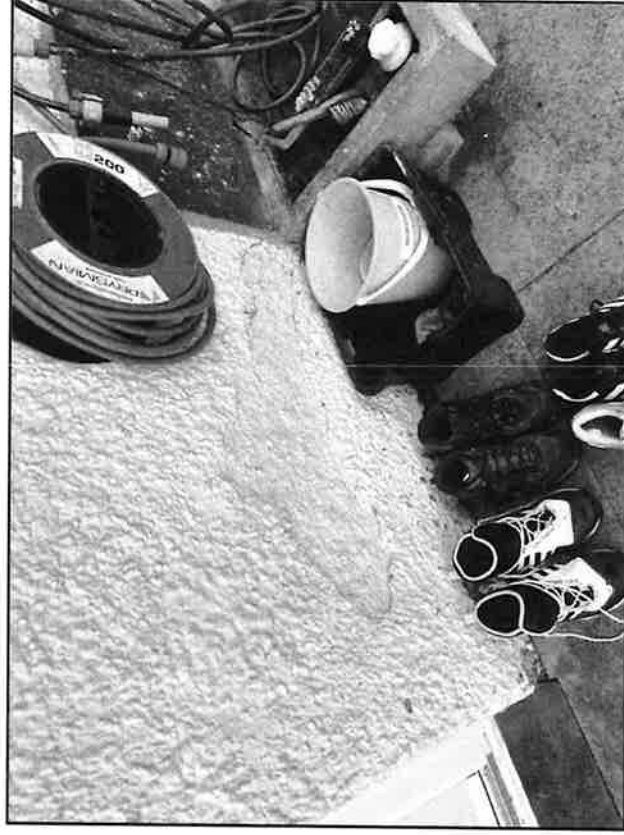
027. Area of spalled render finish at front elevation

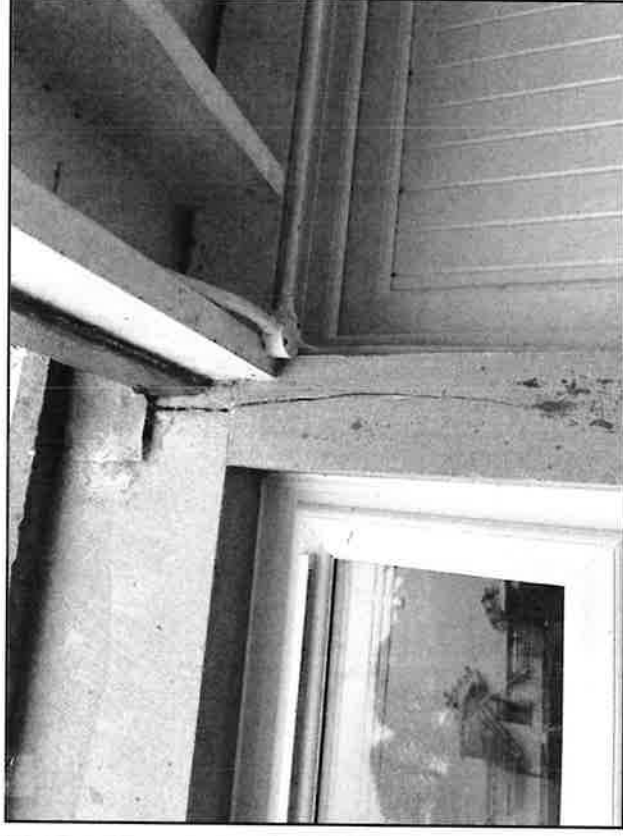
028. Vertical crack, wider at the top, to stone window detail to LHS of front elevation

| High Bursar Activity Centre - Condition Survey Budget Costs | | | | | | | | |
|---|---|---|---|---|---|---|---|---|
| 2.11 | | Vertical crack to stone window detail to LHS of front elevation | Fill with cement render and monitor going forward for signs of opening up suggestive of movement | £ | 0 | £ | 50.00 | £ |

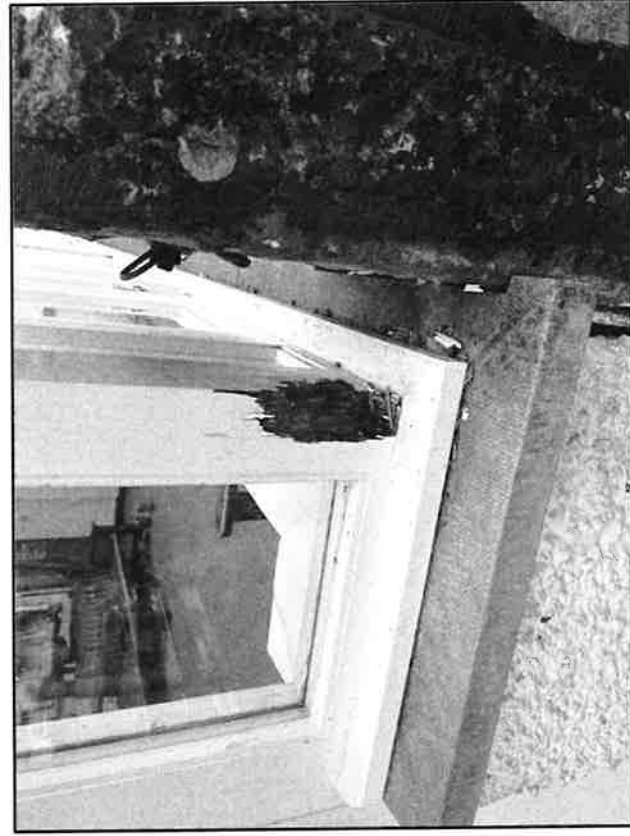
029. Volume loss of timber window unit due to rot to conservatory

| High Bursar Activity Centre - Condition Survey Budget Costs | | | | | | | | |
|---|---|---|---|---|---|---|---|---|
| 2.4 | | All remaining timber windows and door units are ageing | Undertake a window and door replacement scheme | £ | 0 | £ | 17,000.00 | £ |

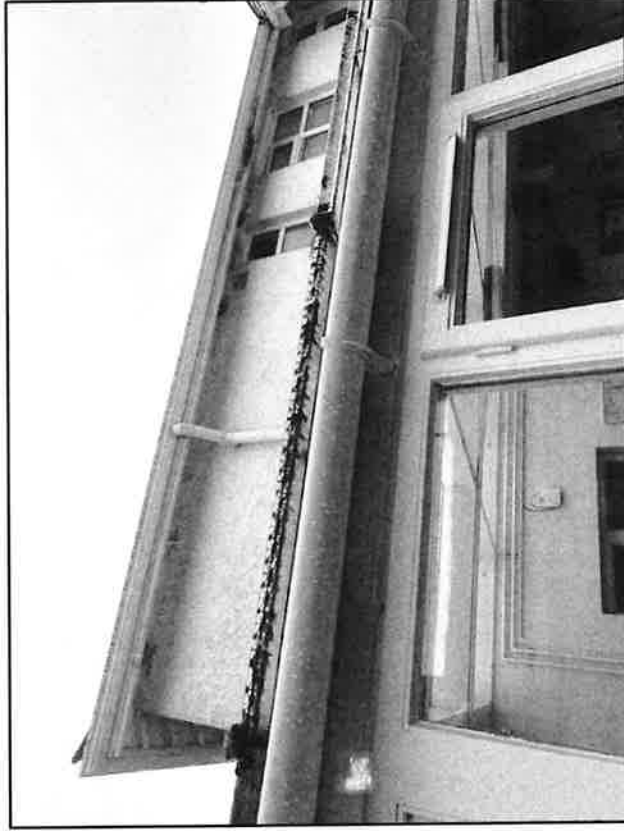
030. Edging missing to polycarbonate sheeting atop conservatory

| High Bursar Activity Centre - Condition Survey Budget Costs | | | | | | | | |
|---|---|---|---|---|---|---|---|---|
| 2.10 | | Edging missing to 1N polycarbonate sheet along car park driveway | Re-install the clear side edging | £ | 0 | £ | 30.00 | £ |

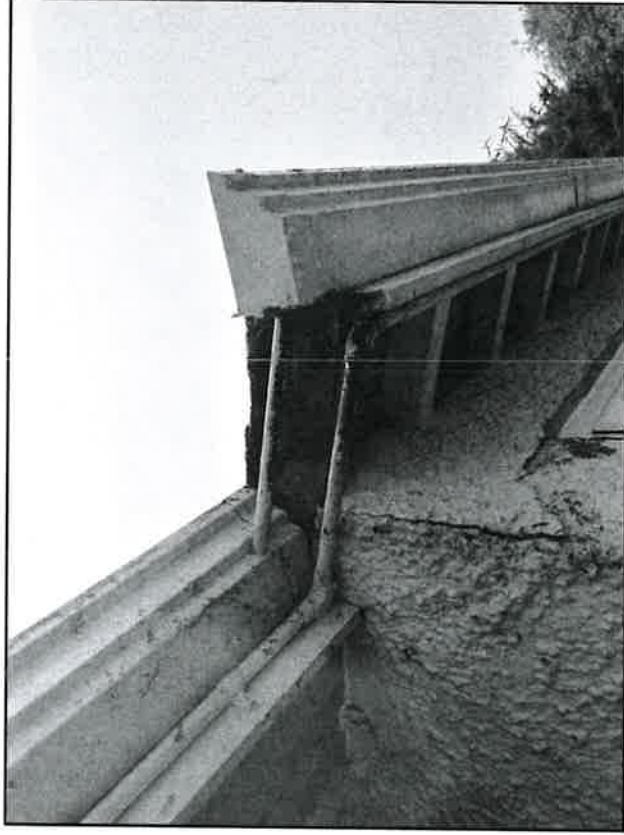
031. Crack to render and missing section of fascia to  
G29 Laundry Room

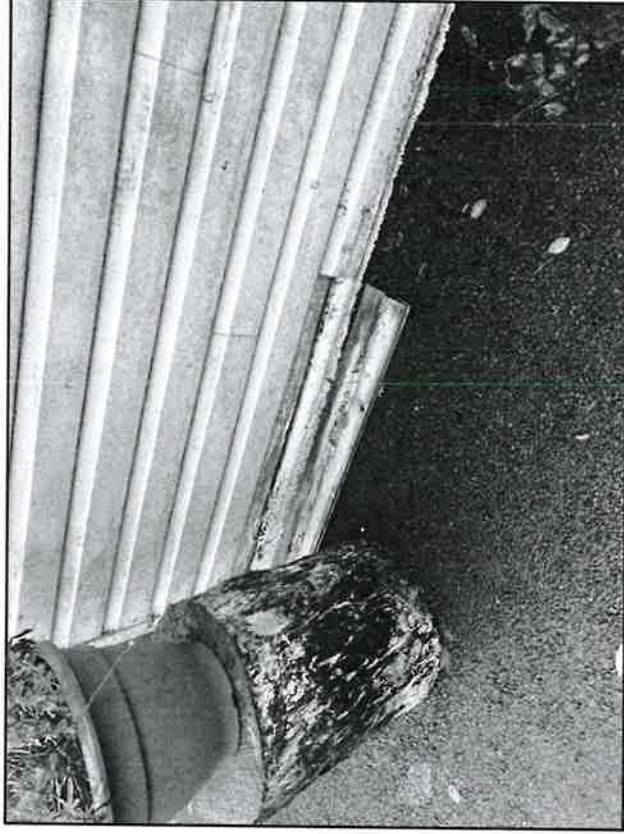
032. Displaced section of timber cladding to front  
elevation G31 Equipment store

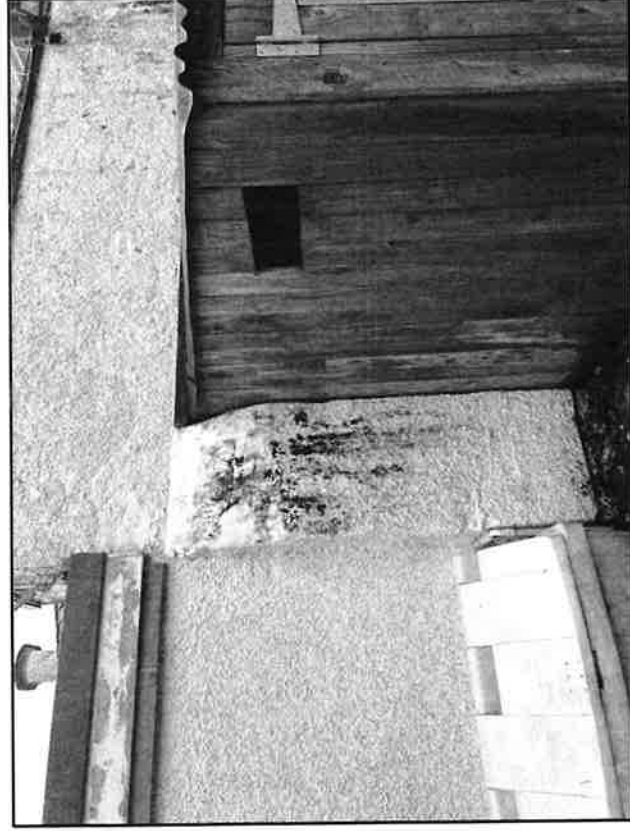
033. Further staining and moss growth to render adjacent to generator at front elevation

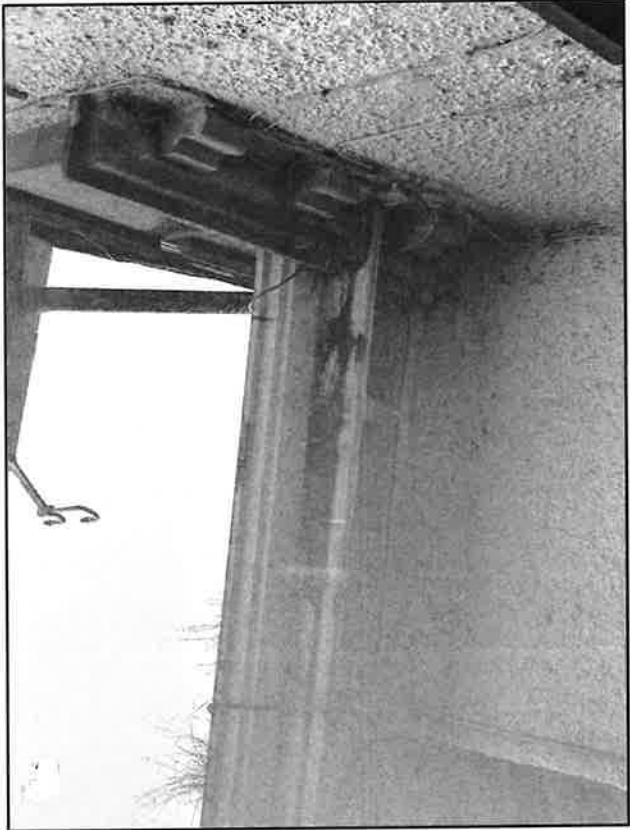
034. Example of fascias in poor condition throughout

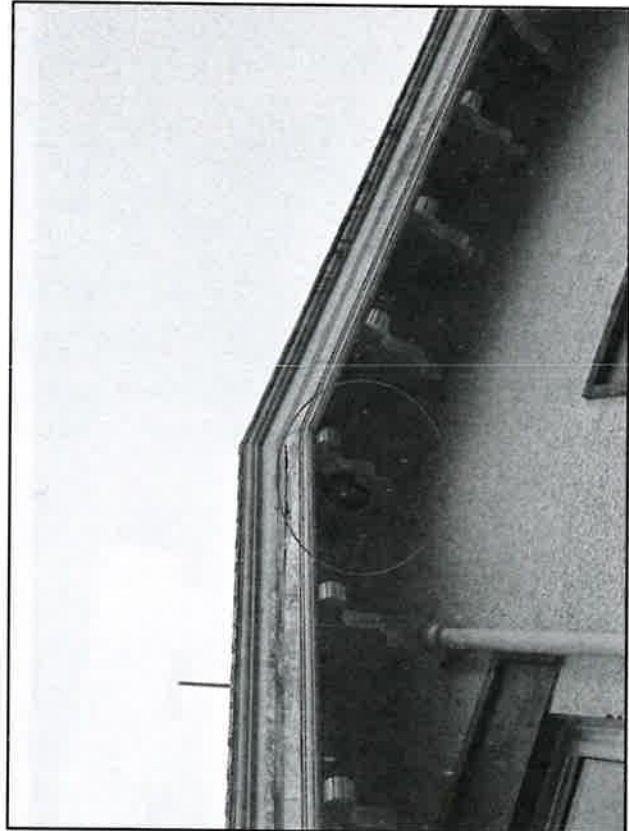
035. Section loss to decorative timber soffit detail at front elevation

| High Bursar Activity Centre - Condition Survey Budget Costs | | | | | | | | |
|---|---|---|---|---|---|---|---|---|
| 2.5 | | Section loss to decorative timber eave detail at front elevation | Take down existing soffits and fascias, replace with new, including decoration | £ | 0 | the m 2.7 | £ | the m 2.7 |

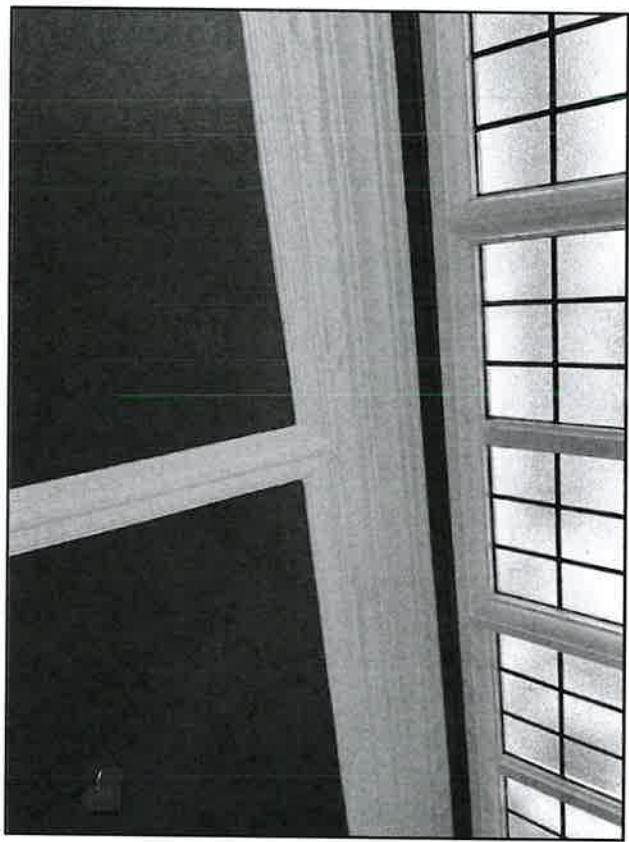
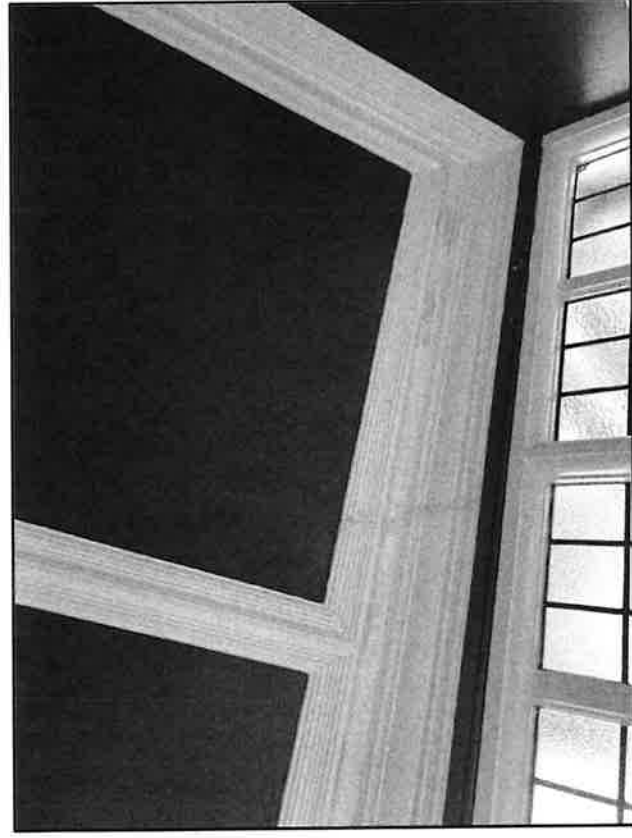
| | Hairline crack mirrored on RHS and LHS of plaster coving to porch | Widen, fill with suitable filler and decorate. | 036, 037 |

036. Hairline crack to plaster coving and ceiling at RHS of porch

037. Hairline crack to plaster coving and ceiling at LHS of porch

| 3.17 | Horizontal crack mirrored on RHS and LHS of plaster above to porch | Widen, fill with suitable filler and decorate | £ | - | £ | inc in 3.14 | £ | - | £ | - | £ | inc in 3.14 |

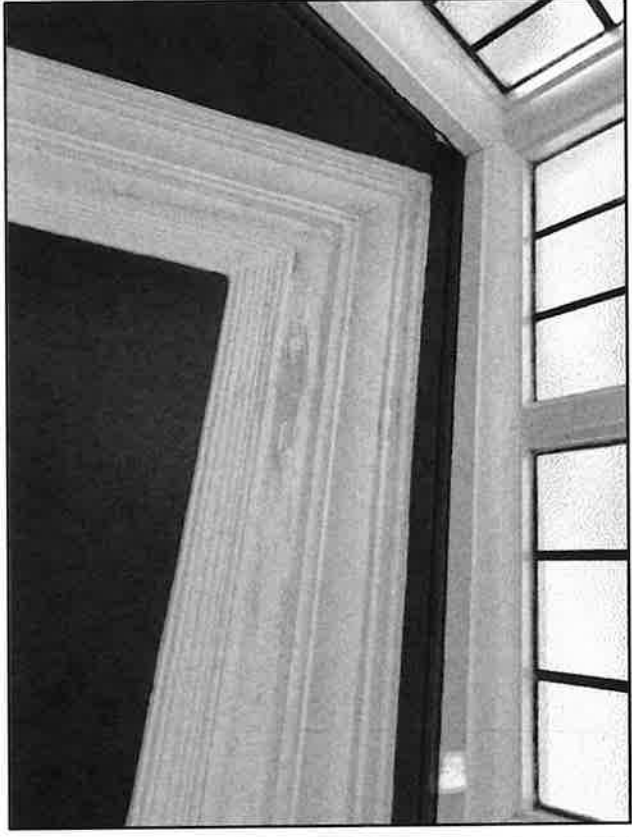
| | Finding | Recommendation | Photo |
|--|---|---|---|
| | Mould growth noted within Grasmere bedroom, porch, 029 Laundry room, drying room and to most WCs and showers | Clean down with anti-fungal cleaner<br>Apply stain block and decorate with anti-mould emulsion to previously mould affected areas | 038, 061, 066, 068, 069, 076, 080 |

038. Mould growth within unheated porch to coving detail

| 3.8 | Mould growth noted within Grassmere bedrooms, porch, Q27 laundry room, drying room and in most WCs and showers | clean down with anti-fungal cleaner<br>Apply stain block and decorate with anti-mould emulsion to previously mould affected areas | £ | 560.00 | £ | - | £ | - | £ | - | £ | 560.00 |

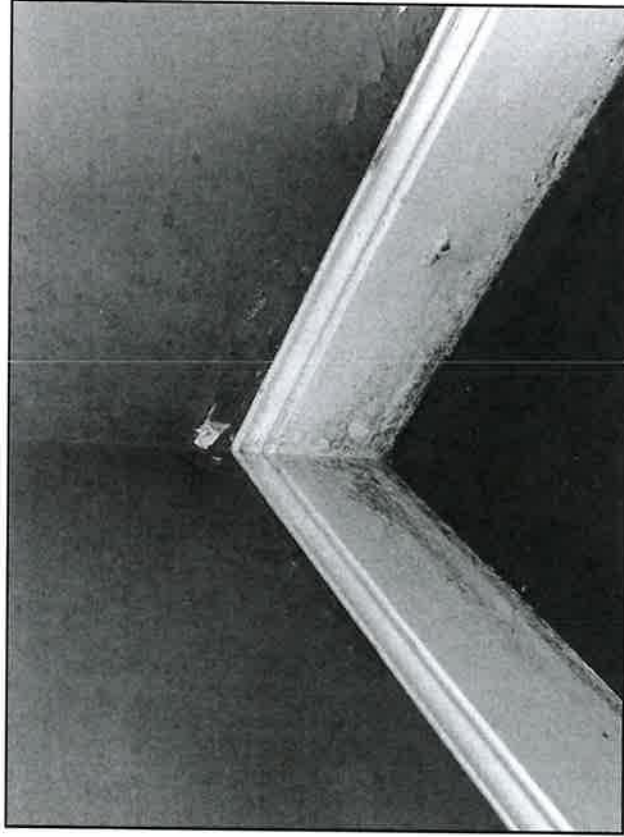
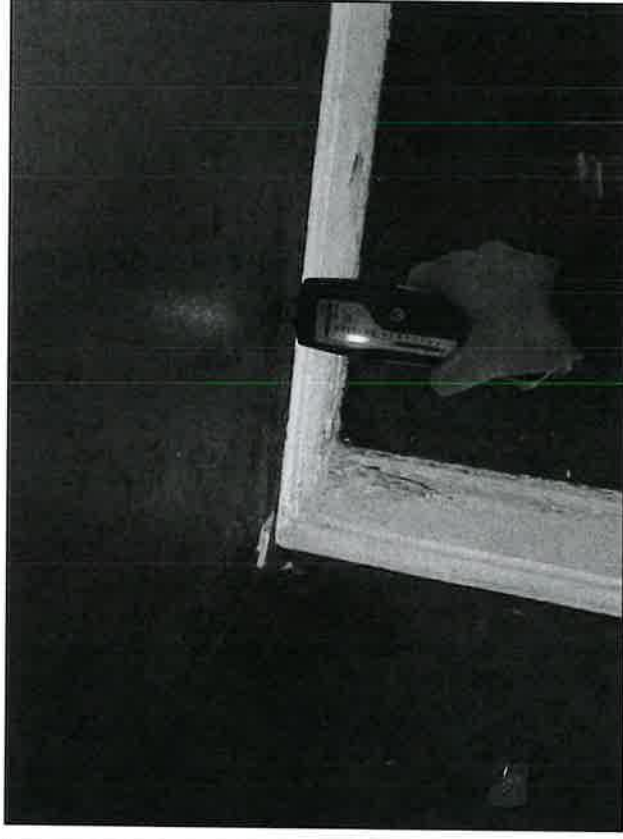
| | Finding | Recommendation | Photo |
|--|---|---|---|
| | Mould & damp affected plaster behind WC & to LHS of external doors in G27 equipment store and to front corner of porch | Clean down with anti-fungal cleaner, apply stain block and decorate with anti-mould emulsion. Source of damp to be remediated through external render repairs | 039, 040, 071, 072 |

039. High damp readings recorded at front LHS of porch at low level

040. High damp readings recorded at front LHS of porch at low level

| 3.9 | Mould & damp affected plaster behind WC & to LHS of external doors in Q27 equipment store and to front corner of porch | clean down with anti-fungal cleaner, apply stain block and decorate with anti-mould emulsion. Source of damp to be remediated through external render repairs | £ | 425.00 | £ | - | £ | - | £ | - | £ | 425.00 |
