### **Photographic Schedule**

# High Borrans Activity Centre Photographic Schedule

Windermere, Cumbria, LA23 1JS

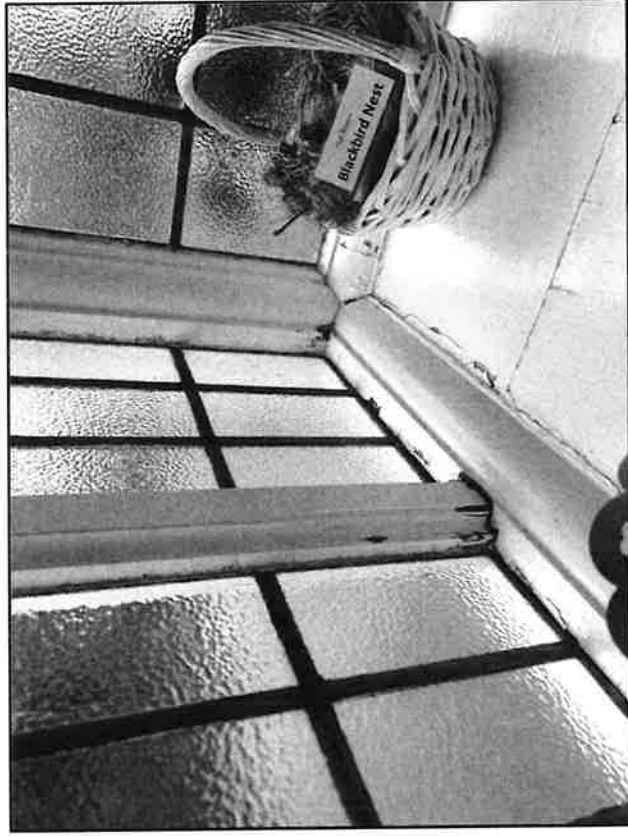
041. Signs of rot to timber window units within porch

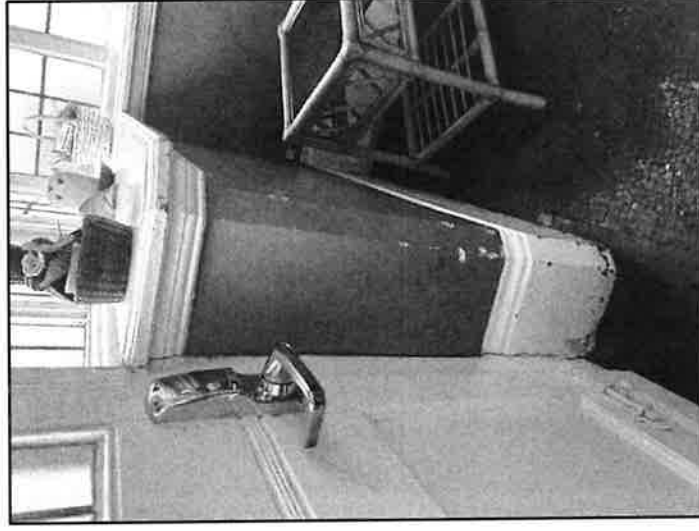
| | Finding | Recommendation | Photo |
|--|---|---|---|
| | Vertical crack to RHS of main entrance within porch | | 042 |

042. Vertical crack to RHS of main entrance

| 3.16 | Vertical crack to RHS of main entrance within porch | Widen, fill with suitable filler and decorate. Monitor going forward for opening up suggesting signs of movement | £ | - | £ | inc in 3.14 | £ | - | £ | - | £ | inc in 3.14 |

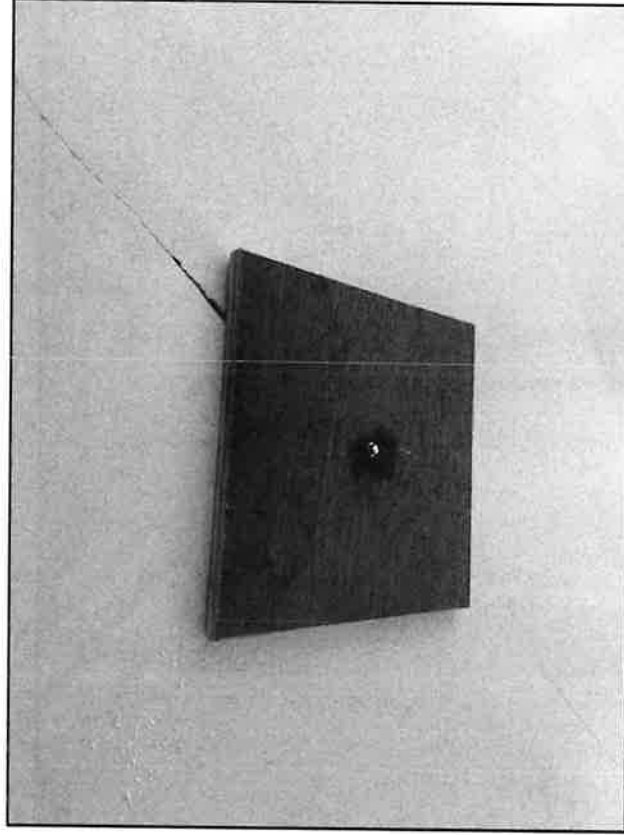
| | Finding | Recommendation | Photo |
|--|---|---|---|
| | Active water ingress within orangery - no access to roof to source cause of water ingress | Rofer to remediate source of water ingress to single storey section<br>Remove damaged plaster ceiling and board out with insulated plasterboard, skim finish & decorate, <i>approx. 15m<sup>2</sup></i> | 043, 044 |

043. Active leak to ceiling within Orangery alongside cracking

044. Blistering to orangery ceiling due to water ingress

| 3.15 | Active water ingress within porchery - no access to roof to source site of water ingress | Refer to remediate source of water ingress in one storey section<br>Remove damaged plaster ceiling and board out with matched plasterboard, skim finish & decorate (approx 15m2) | £ | 300.00 | £ | - | £ | - | £ | - | £ | 300.00 |

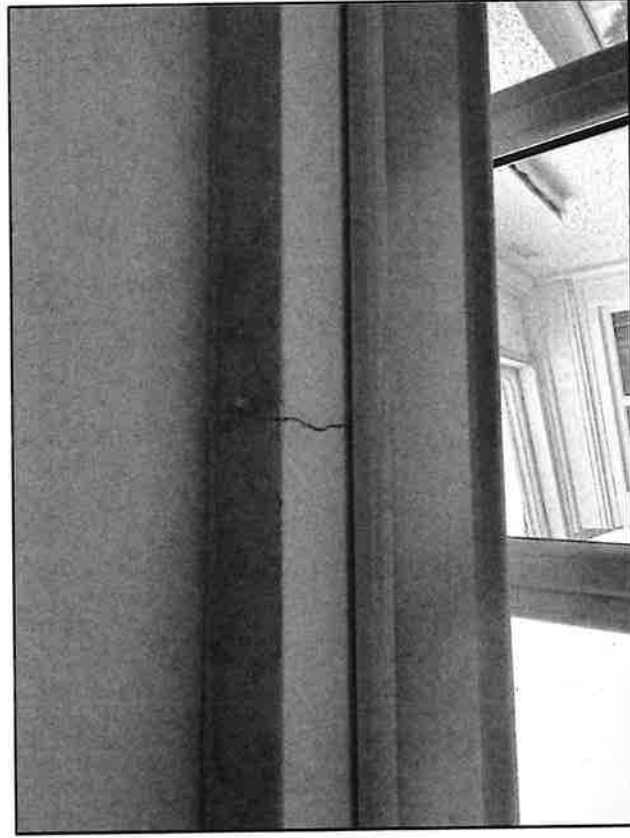
| | Finding | Recommendation | Photo |
|--|---|---|---|
| | Crack to upper window reveal within orangery | Widen, fill with suitable filler and decorate. Monitor going forward for opening up suggesting signs of movement | 045 |

045. Crack to upper window reveal within orangery

| 3.14 | Crack to upper window reveal within porchery | Widen, fill with suitable filler and decorate. Monitor going forward for opening up suggesting signs of movement | £ | - | £ | 225.00 | £ | - | £ | - | £ | 225.00 |

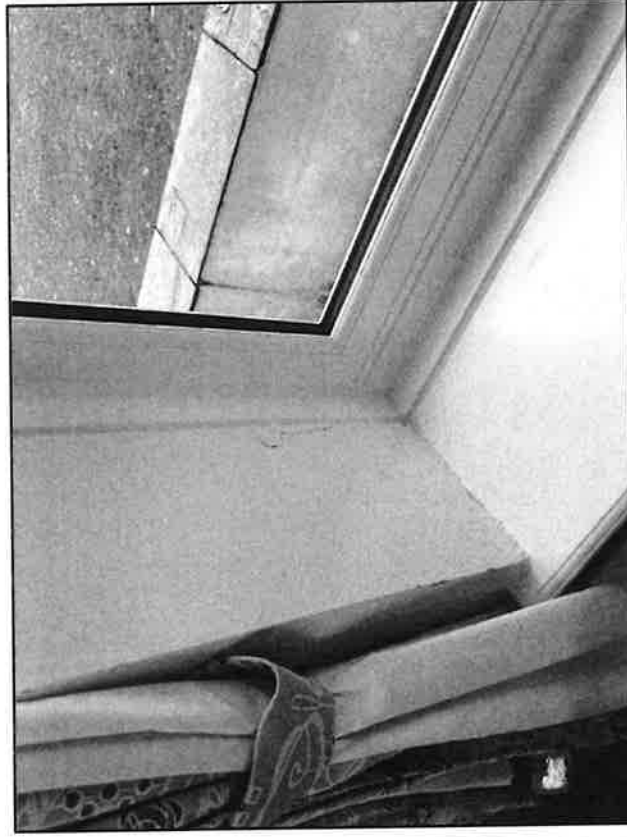
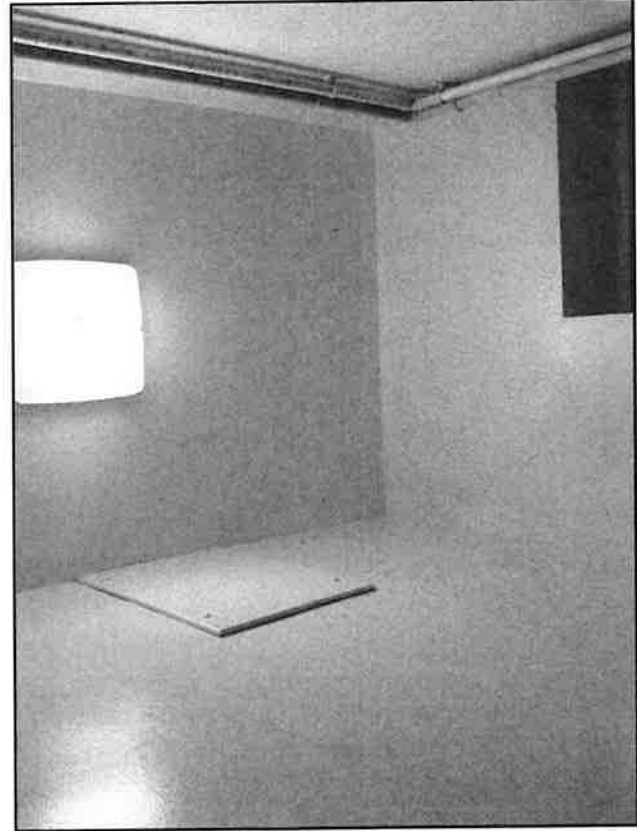
| | Several instances of non-structural cracking to ceilings and walls throughout | Rake out hairline cracks to widen, fill with appropriate filler, prepare and decorate | 046, 049, 054, 056, 057 |

046. Example of non-structural cracking around window reveals, likely to be causing during recent window replacement scheme

049. Hairline crack to corner of ceiling within kitchen pantry

| 3.3 | Several instances of non-structural cracking to ceilings and walls throughout | Take out hairline cracks to widen, fill with appropriate filler, prepare and decorate | £ | - | £ | - | £ | 475.00 | £ | - | £ | 475.00 |

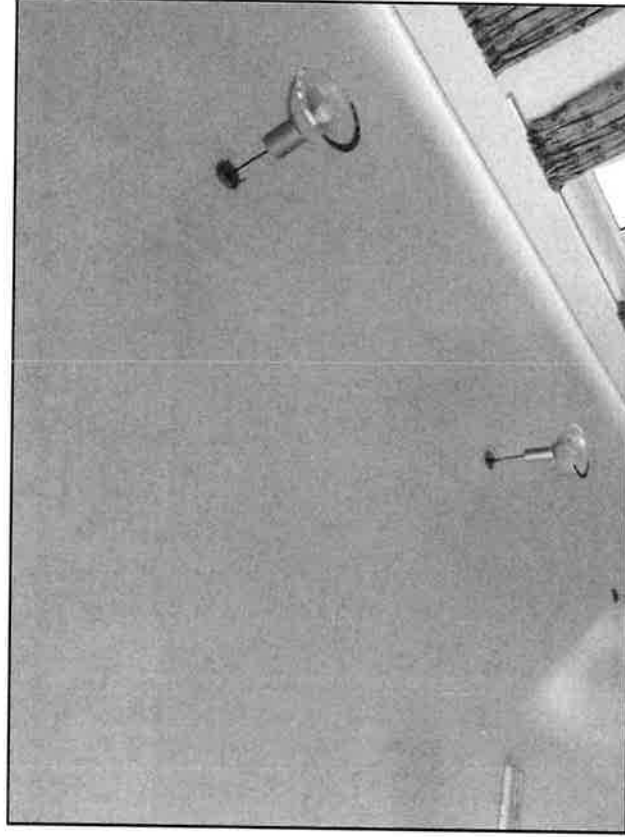
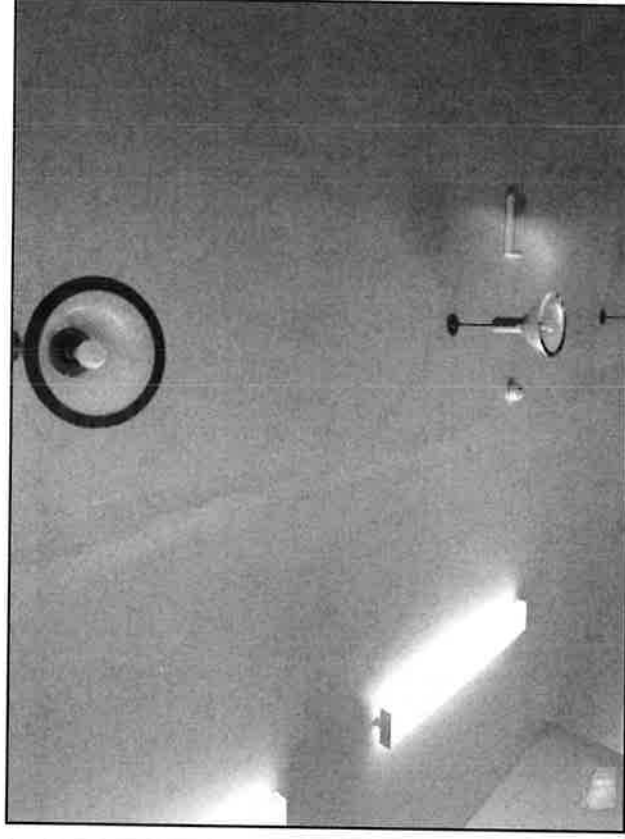
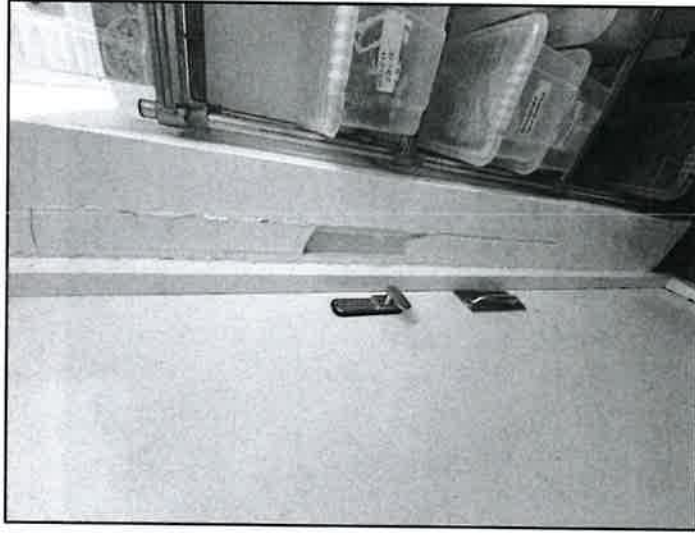
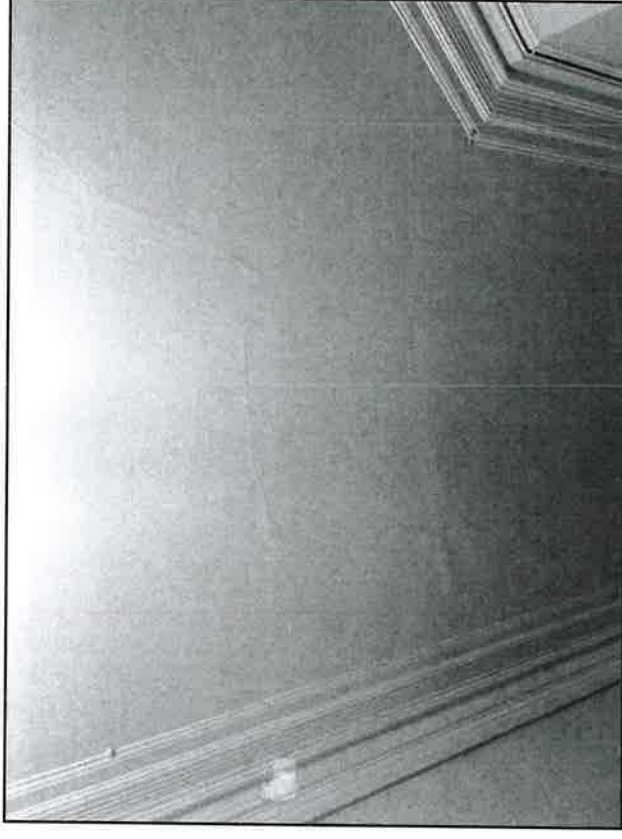
| | Plaster to majority of walls and ceilings throughout has lost its key | Hack off plaster, prepare and re-plaster | 047, 048, 051, 052, 063 |

047. Ceiling within dining room in poor decorative condition, with plaster having lost its key

048. Ceiling within dining room in poor decorative condition, with plaster having lost its key

051. Damage to plaster finished door reveals within food store

052. Decorative damage to painted plaster ceiling within corridor adjacent to main entrance

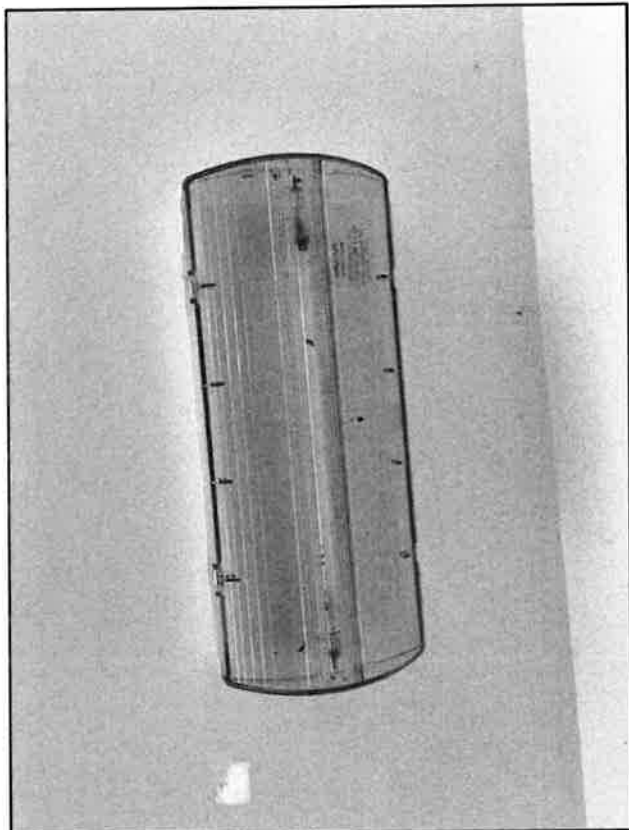
| | Finding | Recommendation | Photo |
|--|---|---|---|
| | Emergency lighting to ceilings throughout had no LED indicator light present | Refer to manufacturer's instructions, where LED indicators should be green and present, enlist an electrician to remediate and leave in working order | 050 |

050. No LED indicator to emergency lighting
