## High Borrans Activity Centre

Windermere, Cumbria,  
LA23 1JS

Building Condition Assessment

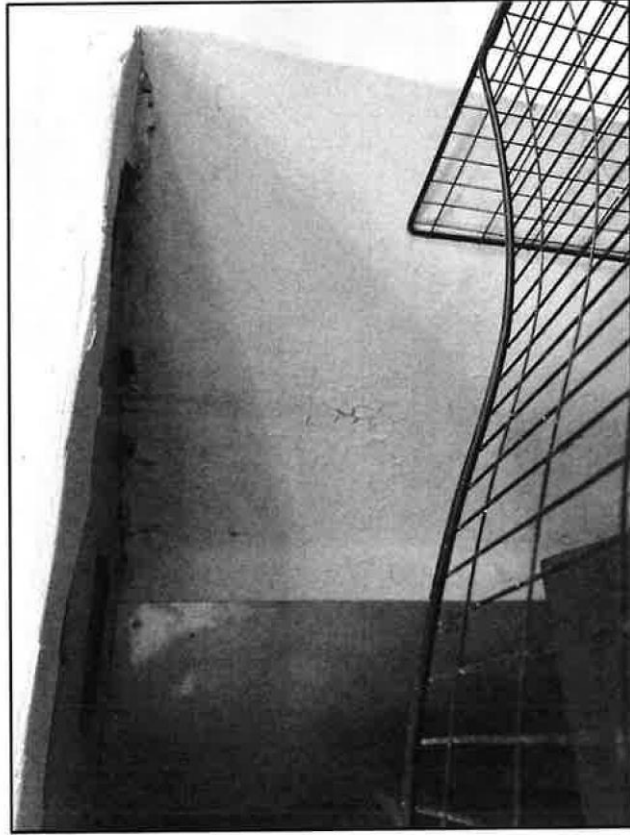
053. Crazeing to plaster within fire place fire box within lounge

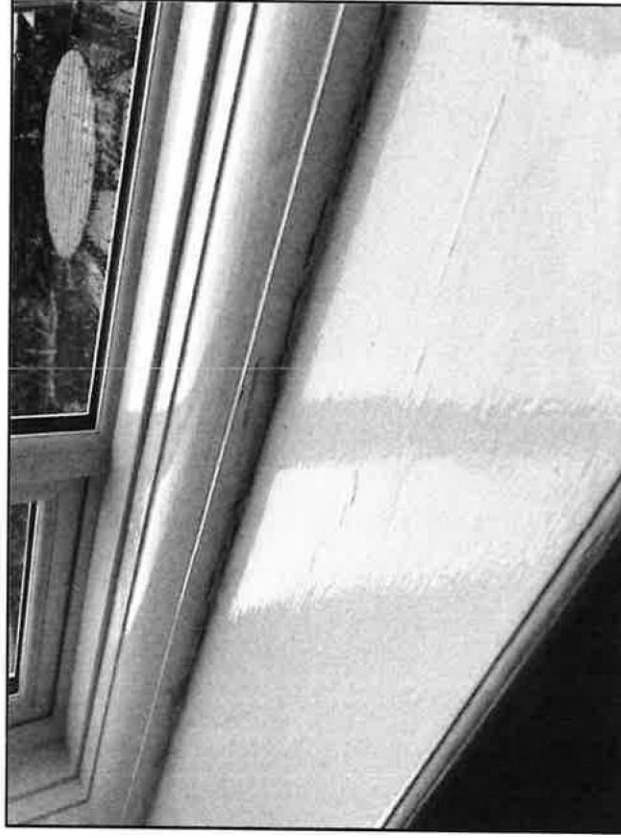
055. Defective seal to sill within Lounge

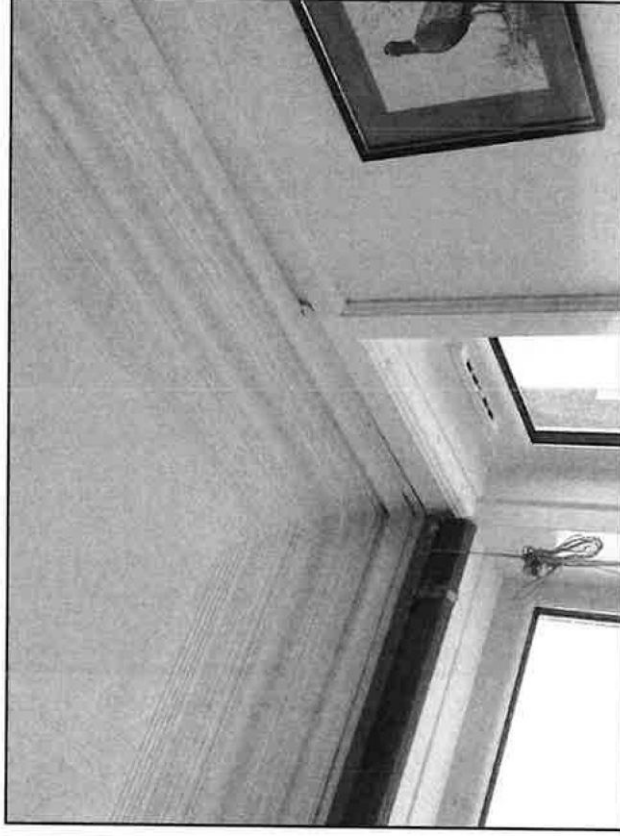
056. Horizontal non-structural crack above window of

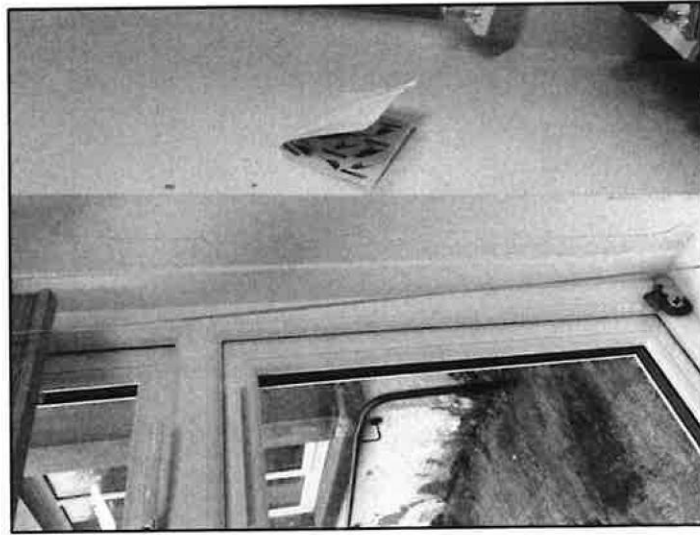
057. Cracking to RHS and LHS window reveals within office G06

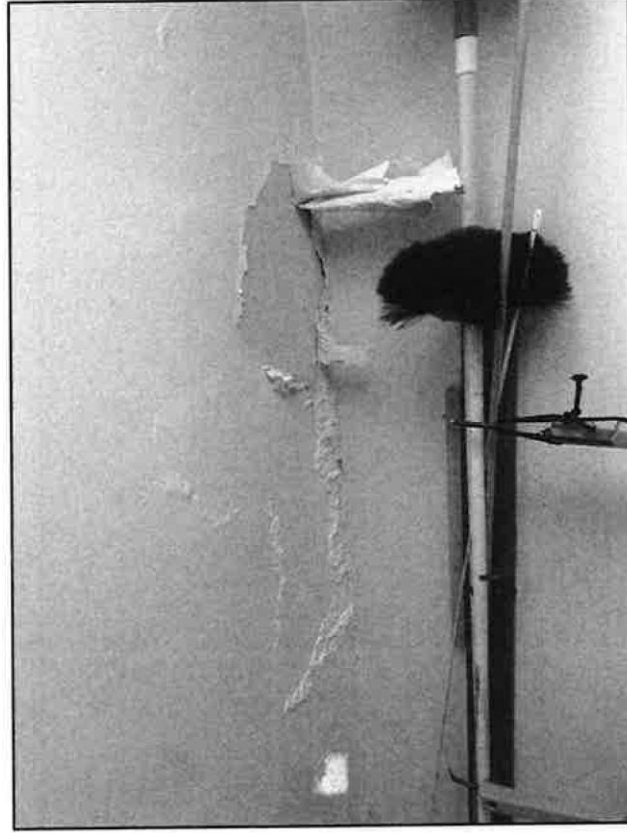
058. High damp meter readings to ceiling at underside of stairs adjacent to G14

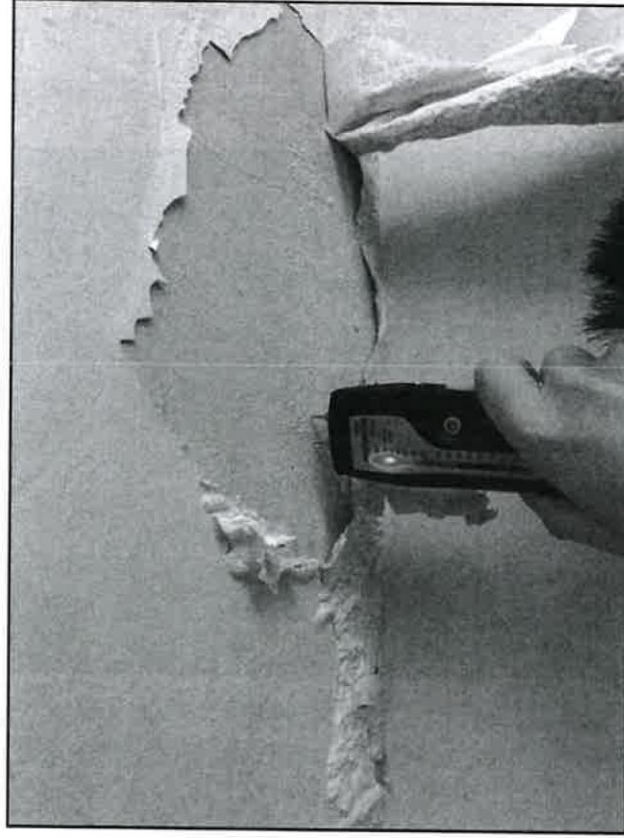
059. High damp meter readings to ceiling at underside of stairs adjacent to G14

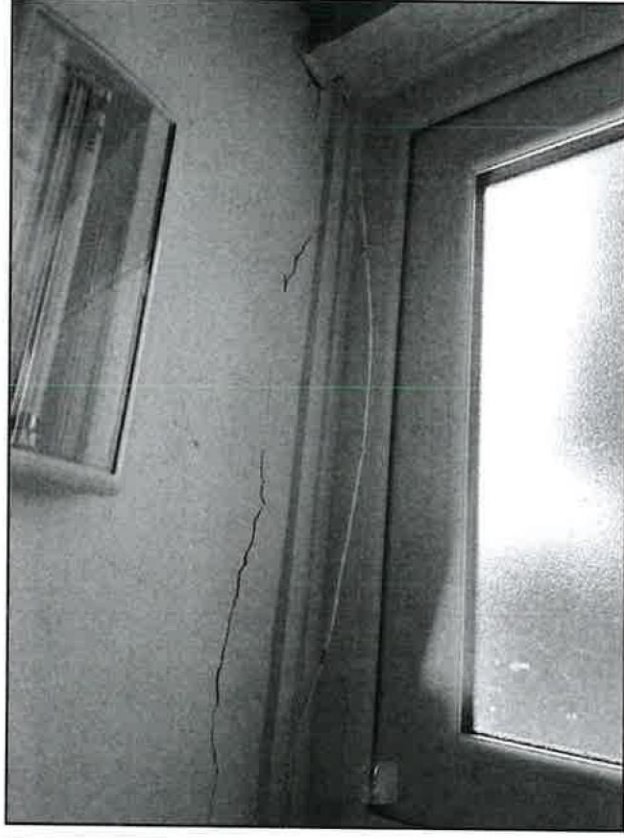
060. Crack to ceiling adjacent to external door at underside of stairs adjacent to G14

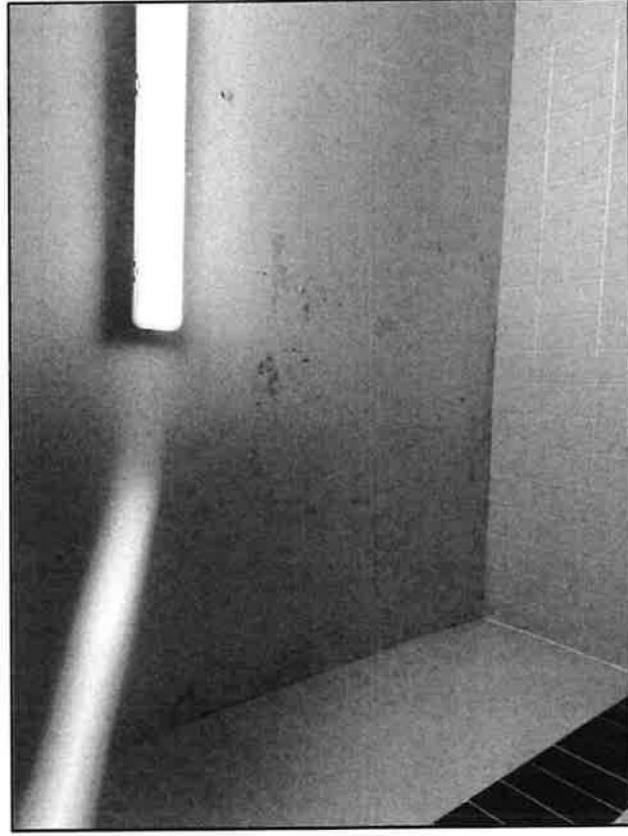
061. Example of mould to ceilings, noted throughout within changing rooms, showers and WCs

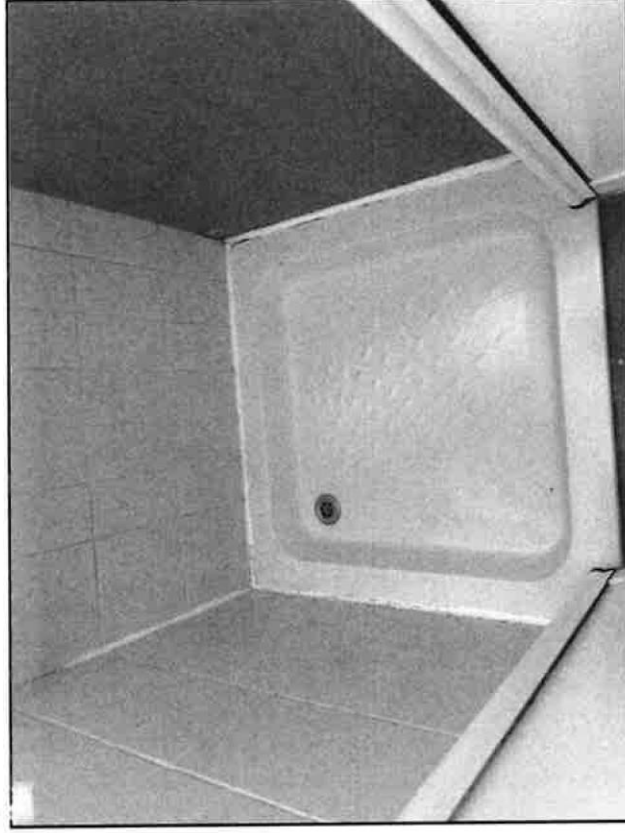
062. Mould affected silicone in aged shower blocks of both male and female showers and throughout

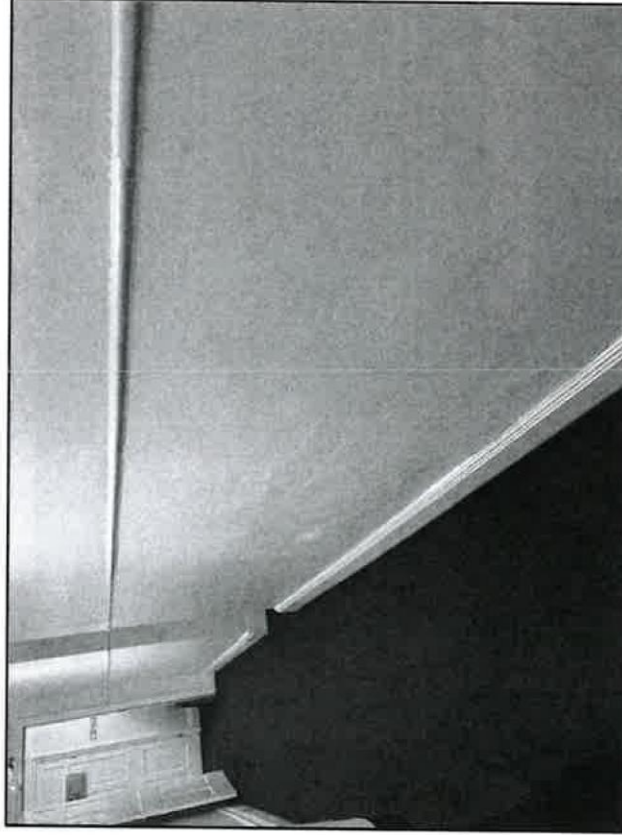
063. Example of plaster finish having lost its key throughout

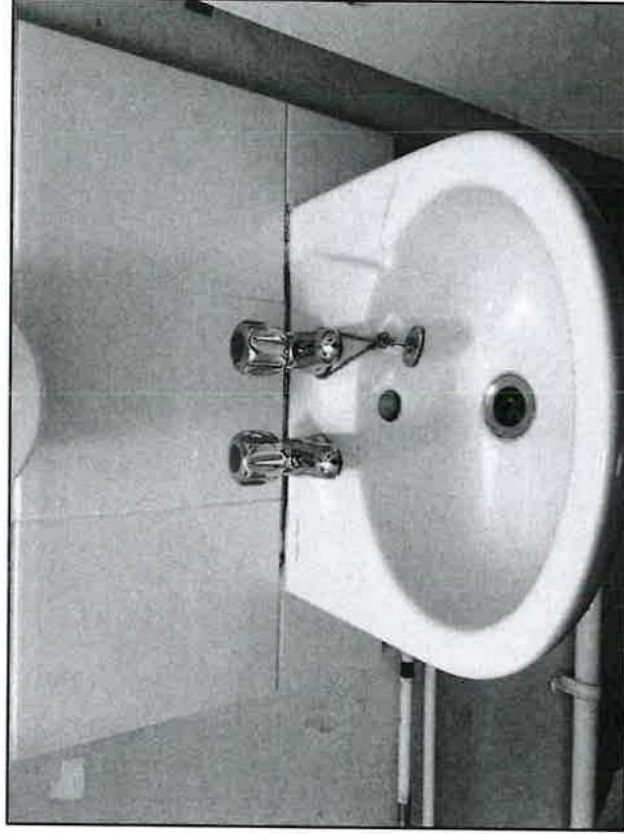
064. Mould affected and defective silicone behind sink of female changing area

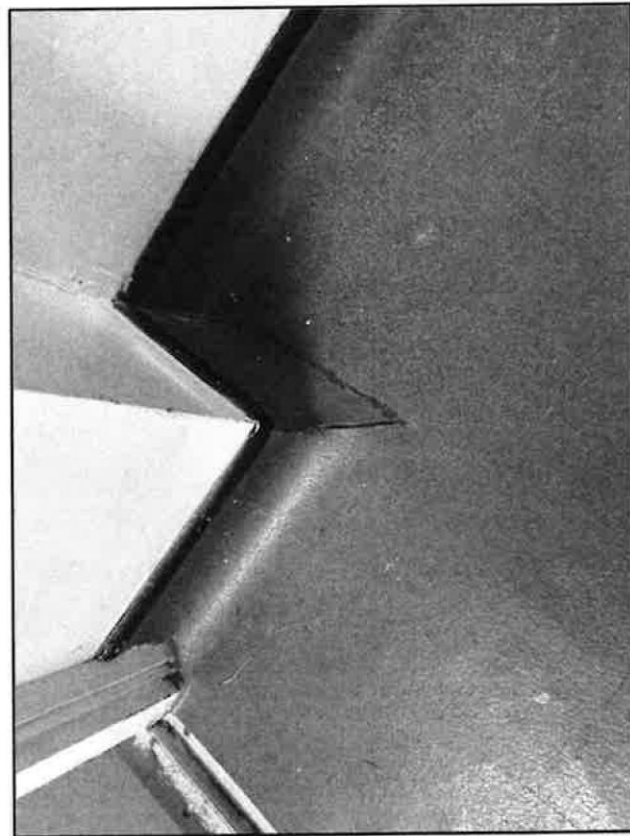
065. Missing mastic from corner joint of safety flooring within female changing area

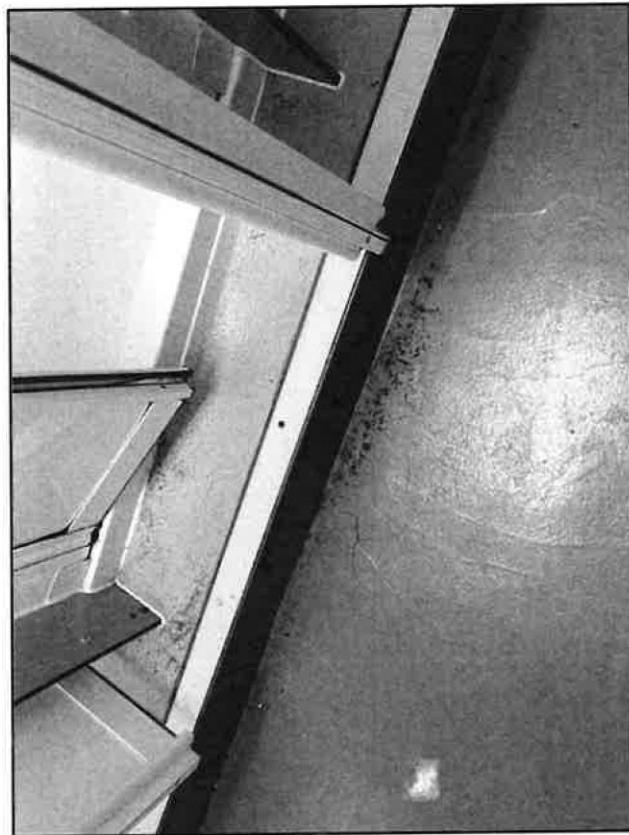
066. Mould to flooring within female changing area/shower block

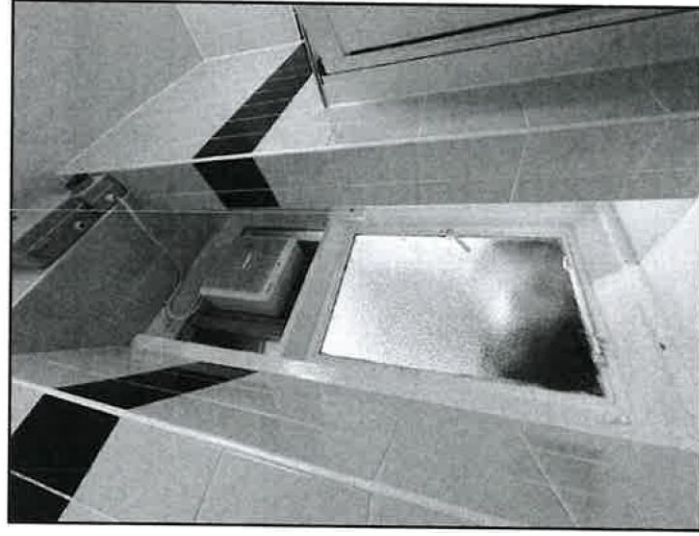
067. Example of few remaining aged timber window  
 single glazed

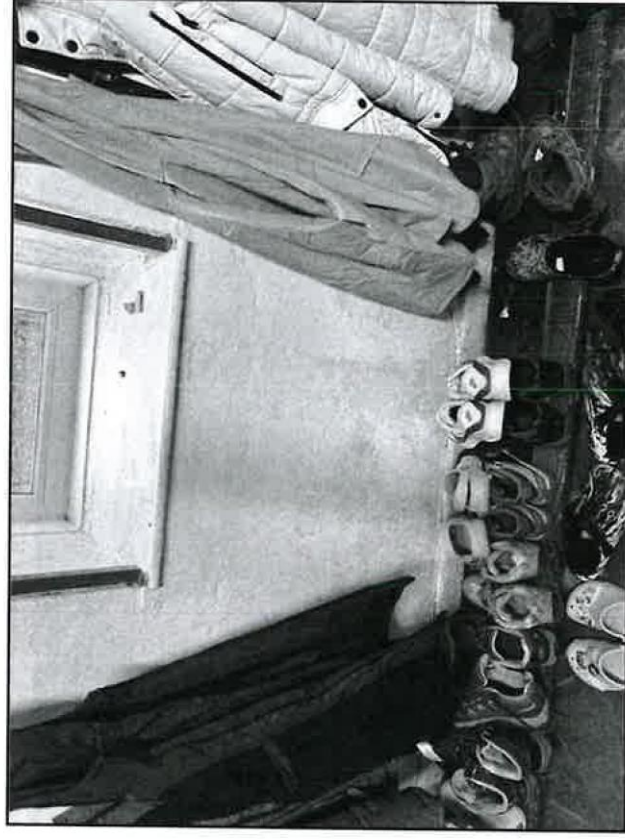
068. Example of mould to walls within drying room

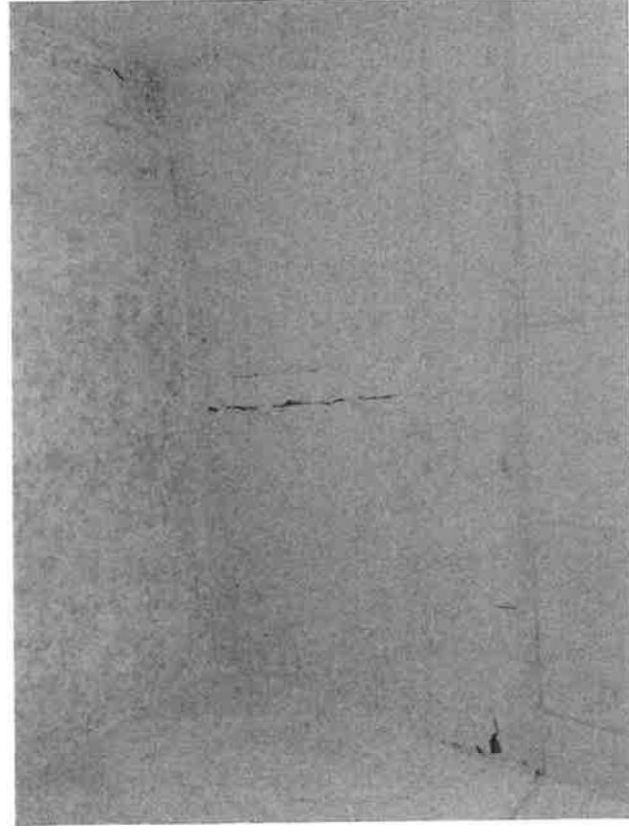
069. Crack to plaster finish and mould above shower within G27 equipment store

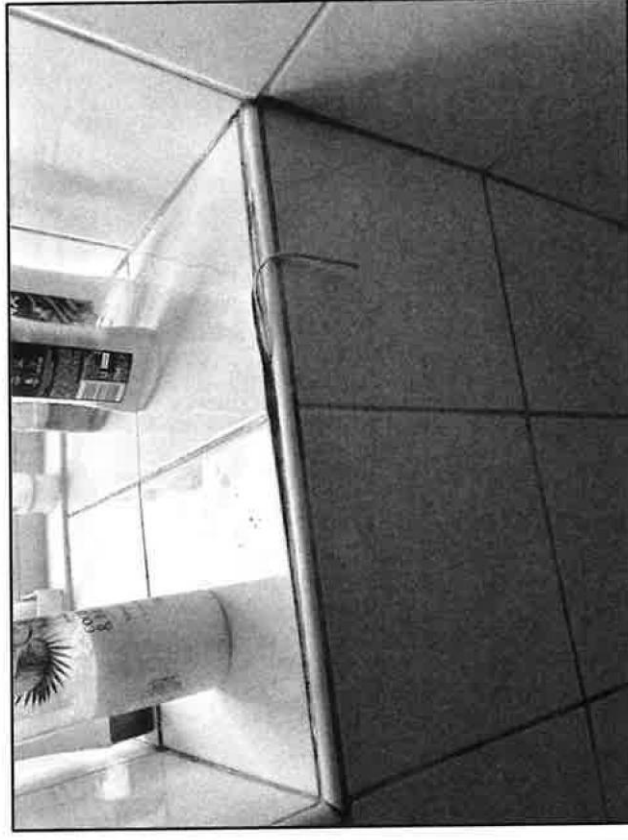
070. Defective silicone between tiles within G27 equipment store

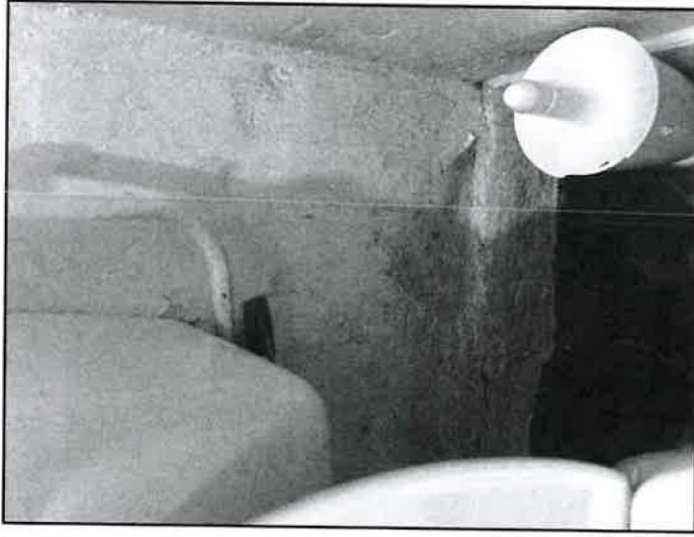
071. Mould and damp affected plaster behind within G27 equipment store

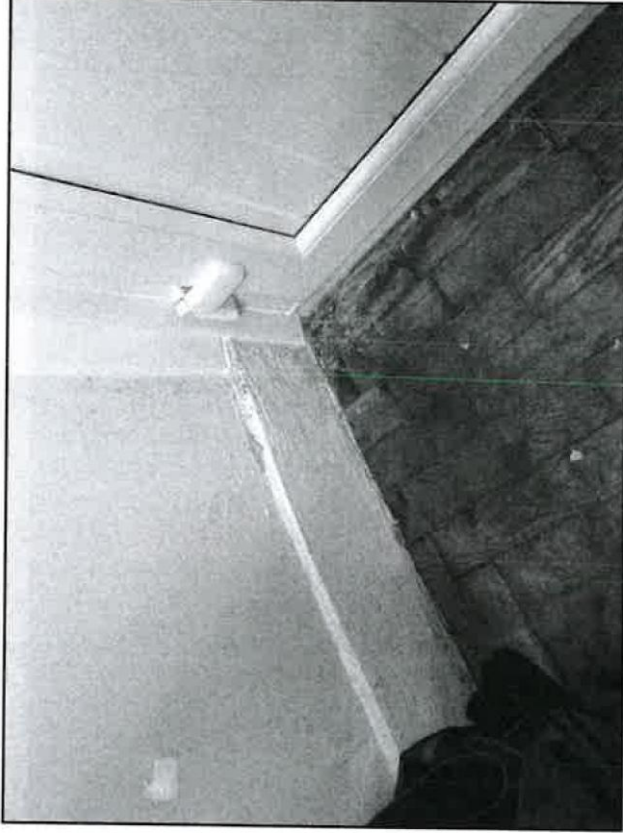
072. Damp affected timber skirting within G27 equipment store

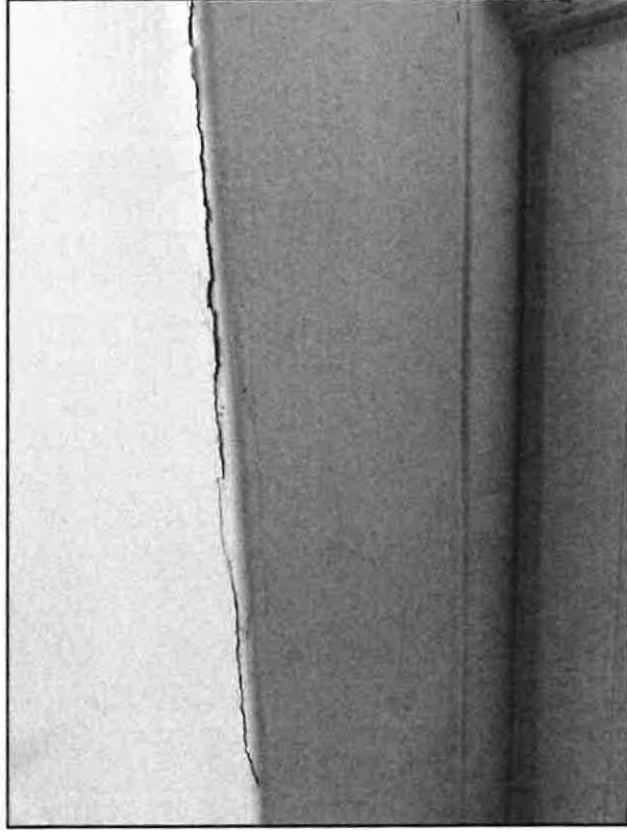
073. Loose plaster above door of G27 equipment store

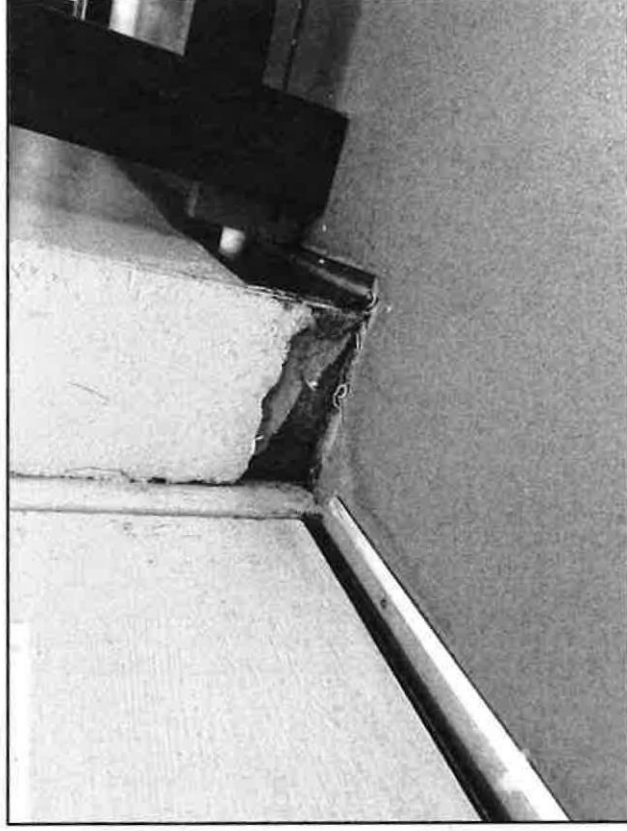
074. Example of missing section of PVC flexible skirting within conservatory

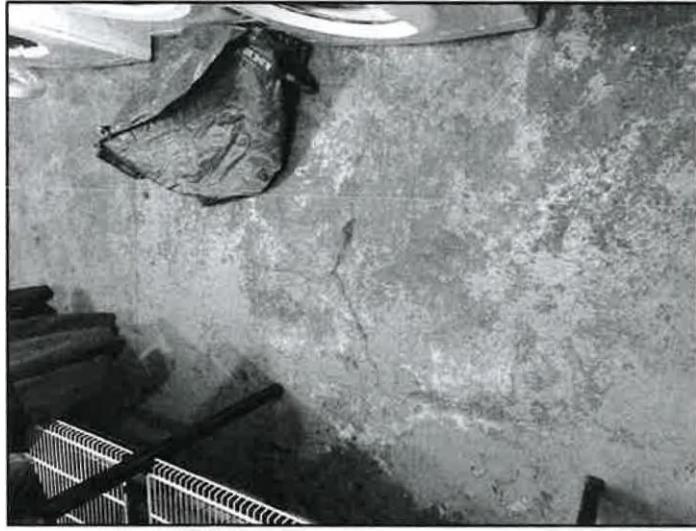
075. Cracking to concrete floor within 029 Laundry

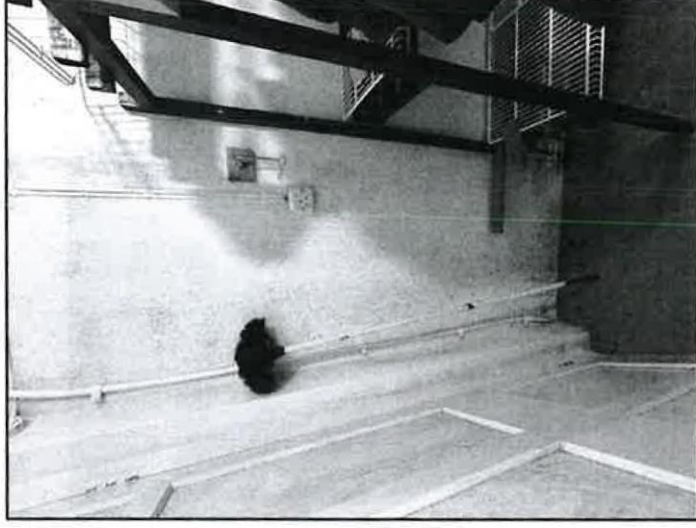
076. Mould to wall within 029 Laundry Room

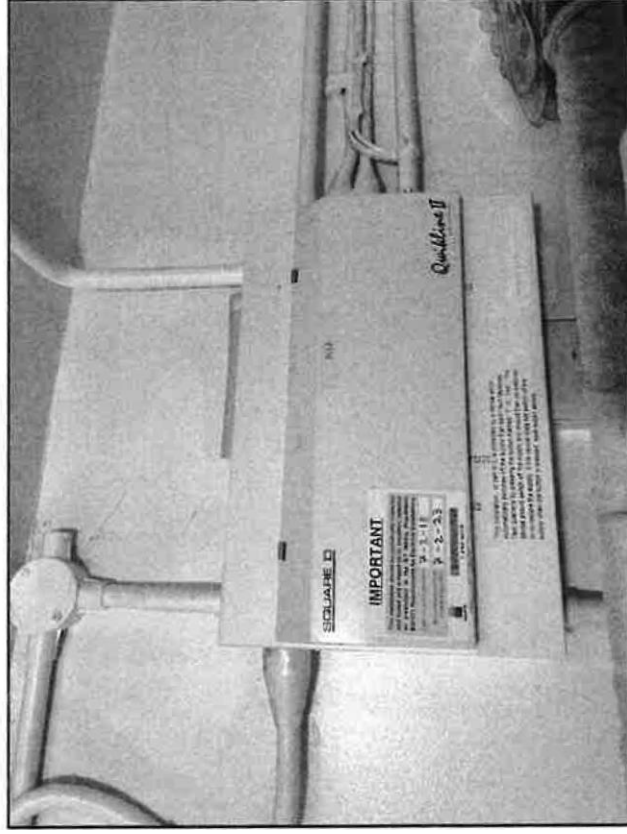
077. DB board marked as being overdue testing within G31/G29

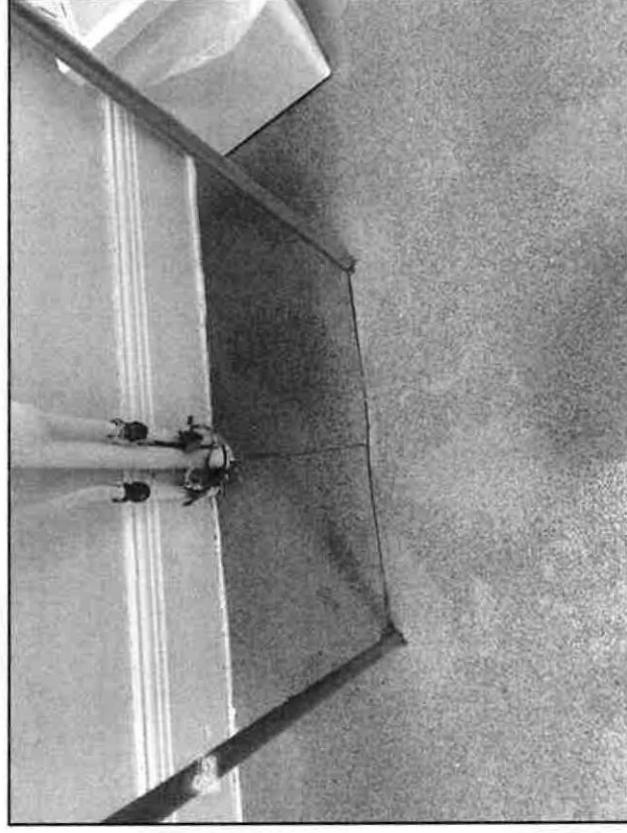
078. Split vinyl below basin within F15 WC

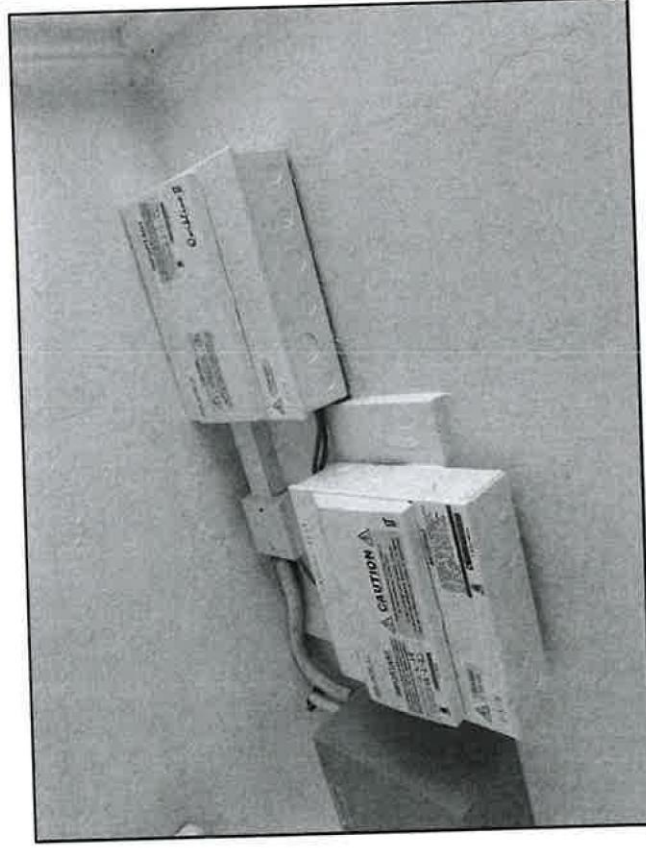
079. DB board marked as being overdue testing to FF  
landing

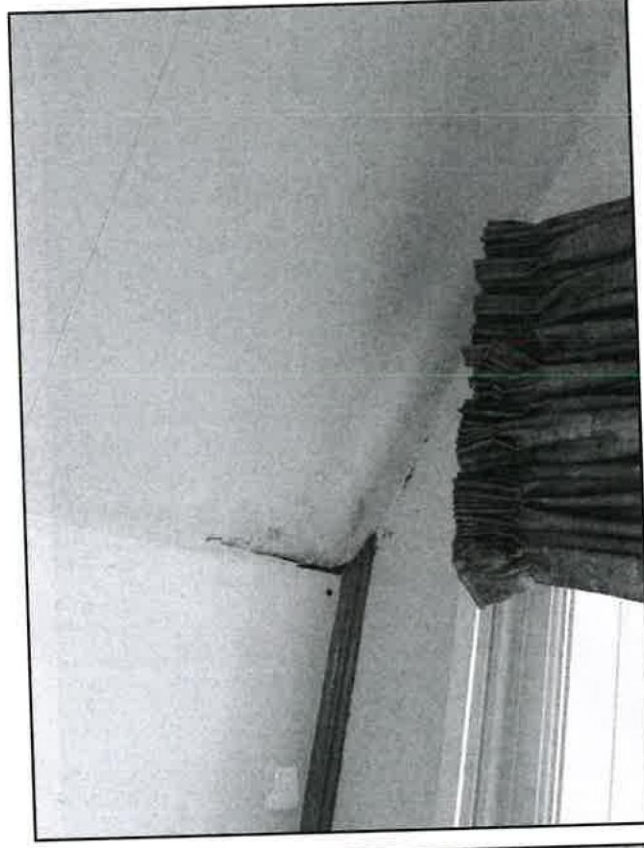
080. Mould to ceiling above bunk bed within  
Grasmere bedroom

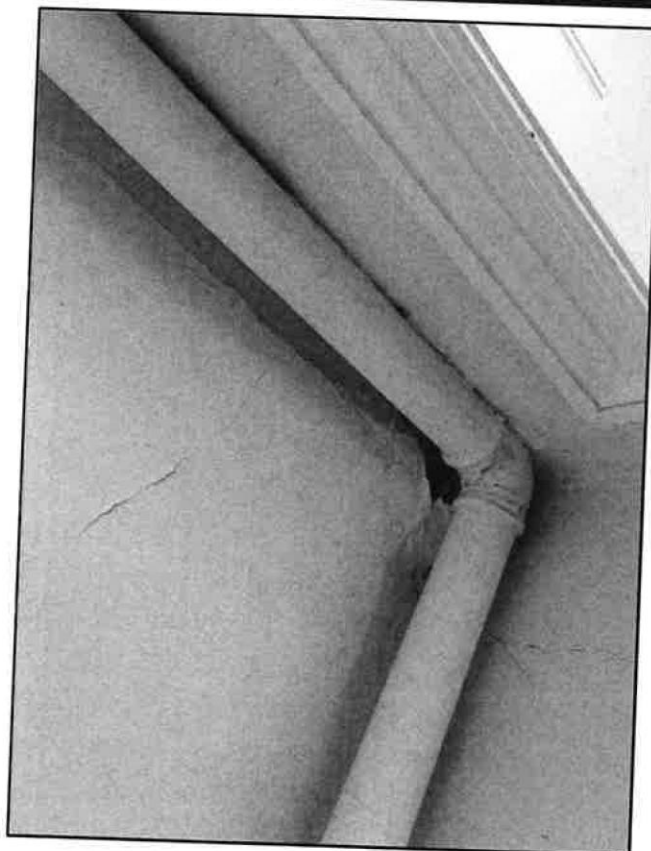
081. Damage to ceiling within WC of Kentmere bedroom
