## **Examination of Failed Threaded Bar Material**

**Client: North Tyneside Council**

The Killingworth Site  
Block A  
Killingworth,  
Newcastle Upon Tyne  
NE12 6QQ

**Document Reference: 1758**

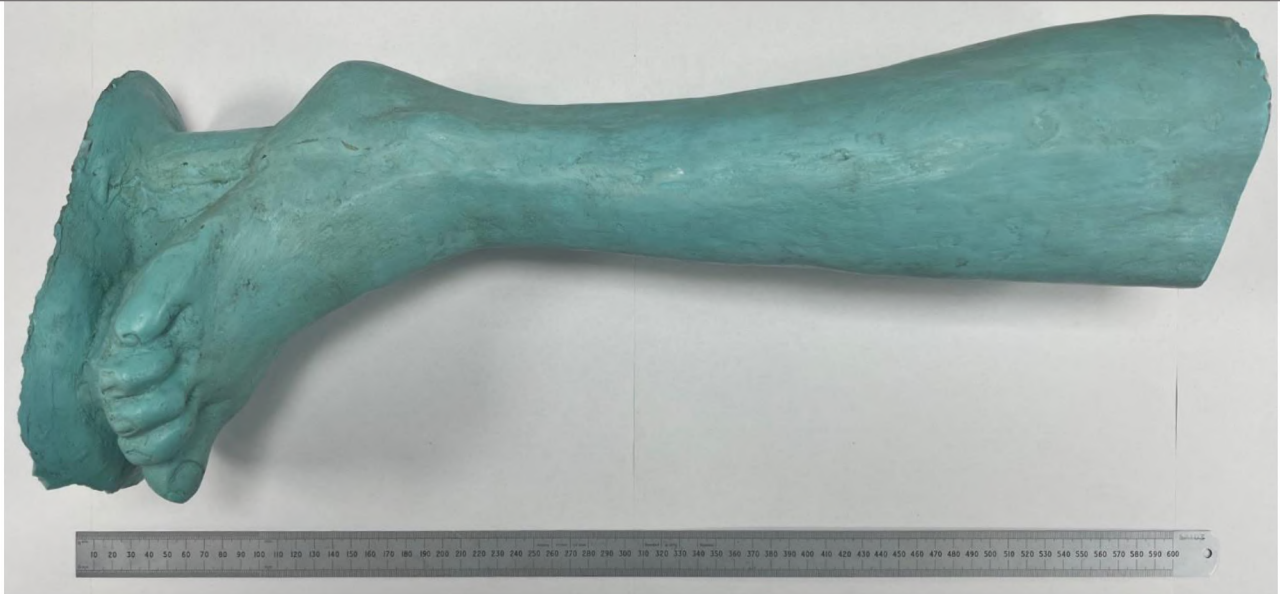
Two sections were received for examination measuring approximately 600mm long which were extracted from a lower part of the armature assembly where the sculpture was secured to the dome of the building. The as-received failed part is shown in Figure 1 to Figure 8, and a second part which was removed before failure from the building is shown in Figure 9 to Figure 11.

**Figure 1: Failed Section as-received**

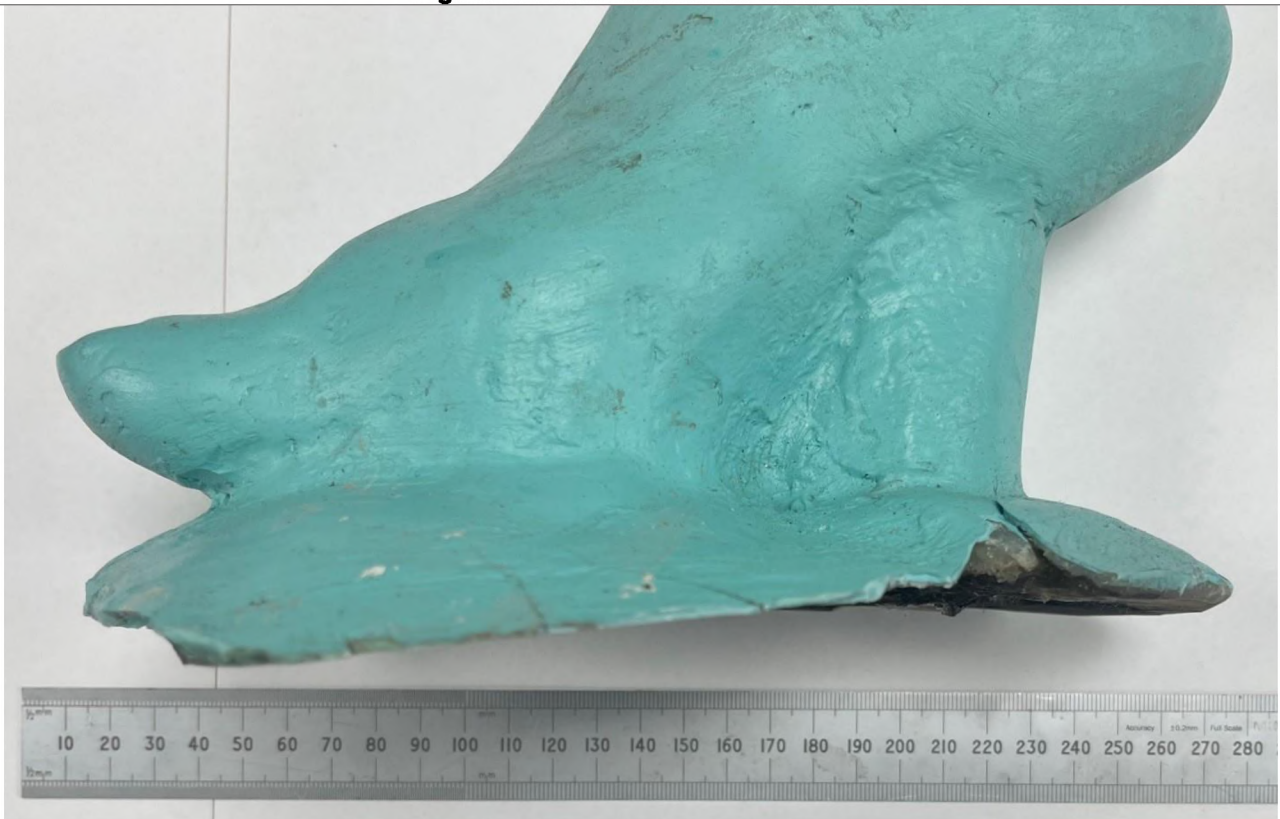
**Figure 2: Failed Section as-received showing lower fracture**

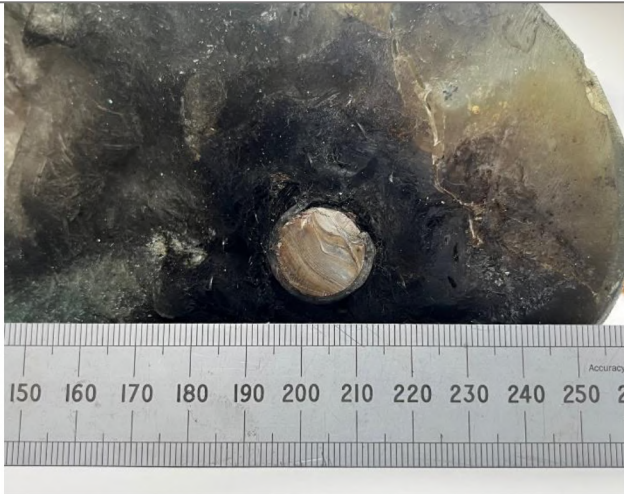
Initial visual examination of the failed part showed a fracture face sited in the central region of the resin statue section. The resin around the fracture showed a discoloured / burnt appearance. (Figure 3 & Figure 4).

**Figure 3: Fracture face of threaded bar and surrounding discolouration**

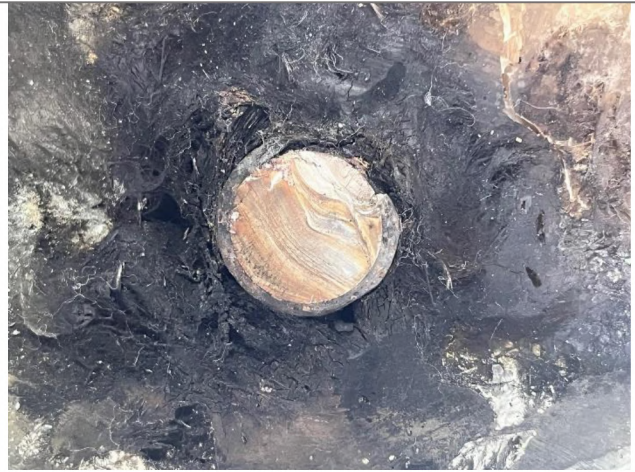
**Figure 4: Fracture face of threaded bar, higher magnification showing fatigue beach marks**

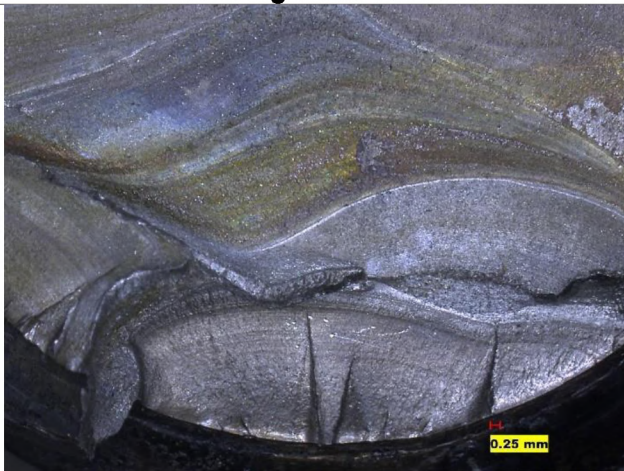
The threaded bar was removed from the resin for further visual examination, which showed a fracture face with prominent beach marks and multiple ratchet marks at the site of initiation on the root of a threaded region. (Figure 5 & Figure 6). The beach marks were consistent with a bending fatigue mode of failure.

**Figure 5: Fracture face of threaded bar showing multiple ratchet marks for crack initiation at the root of a thread**

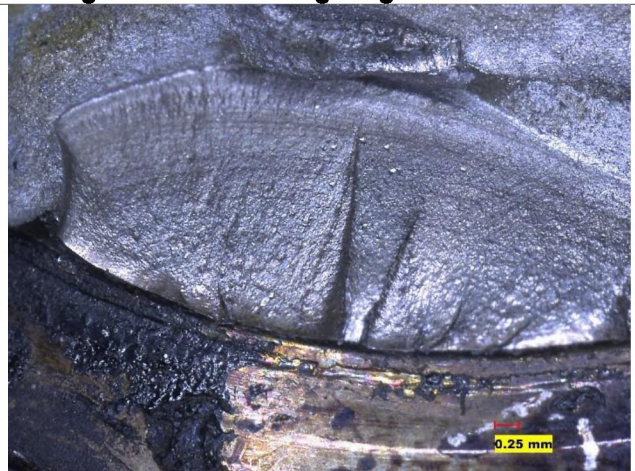
**Figure 6: Fracture face of threaded bar, higher magnification**

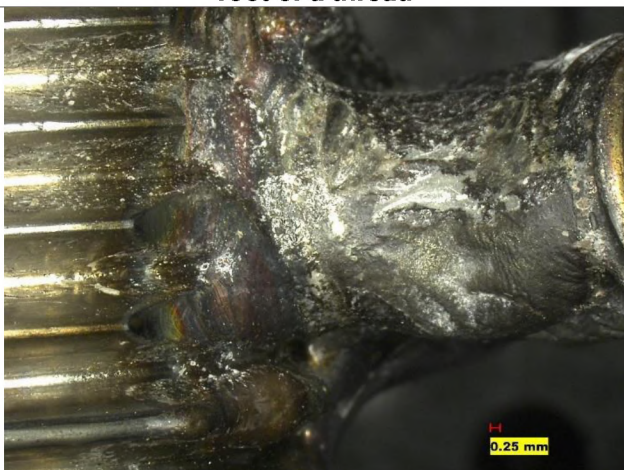
The 20mm threaded bar had small supports / cross sections welded on which showed evidence of excessive heat and melted regions on the outer diameter. (Figure 7 & Figure 8)

**Figure 7: Welded section**

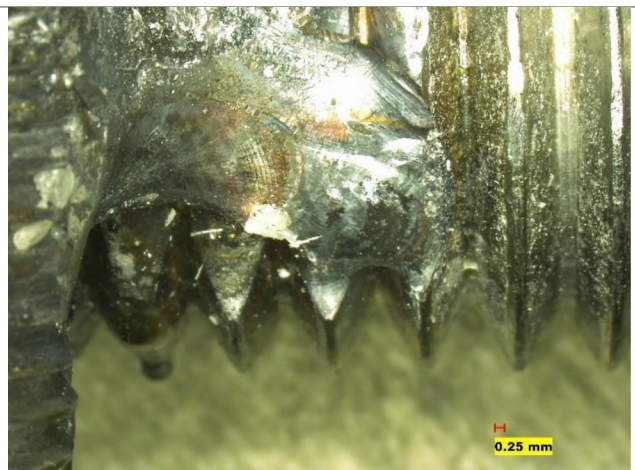
**Figure 8: Welded section showing melted regions due to excessive heat input**

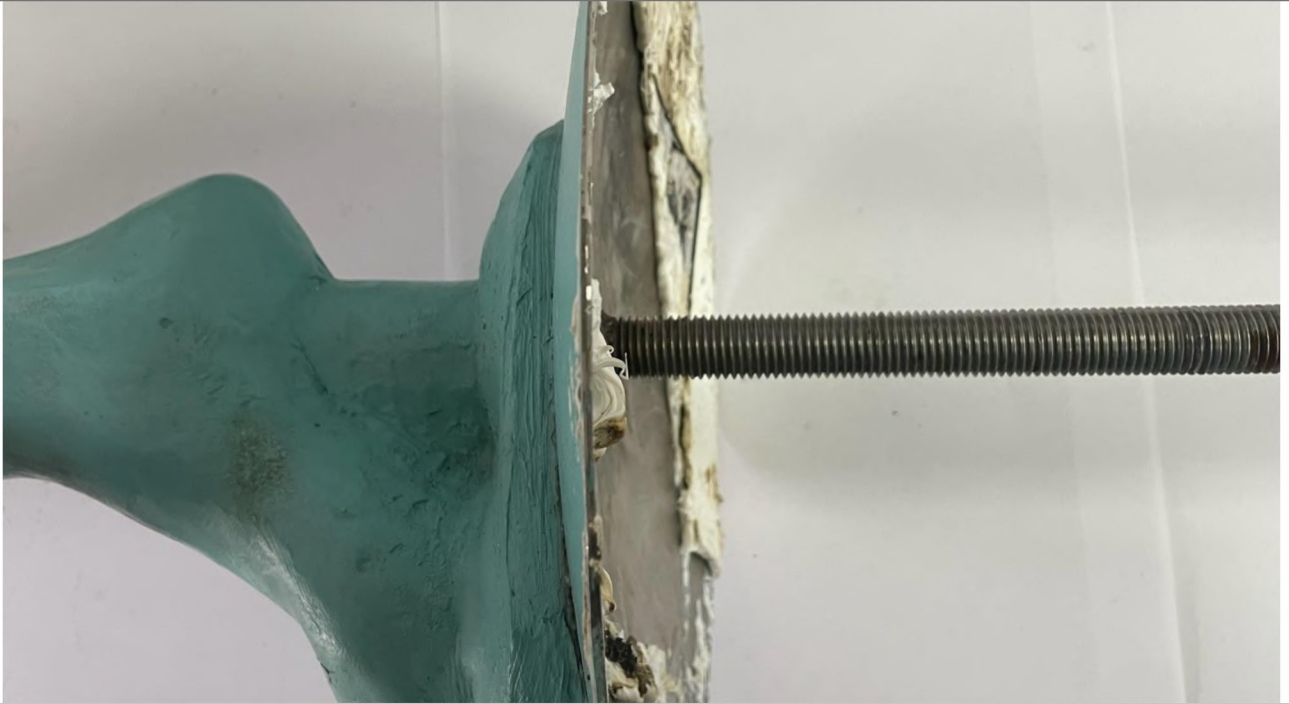
**Figure 9: Intact Section as-received**

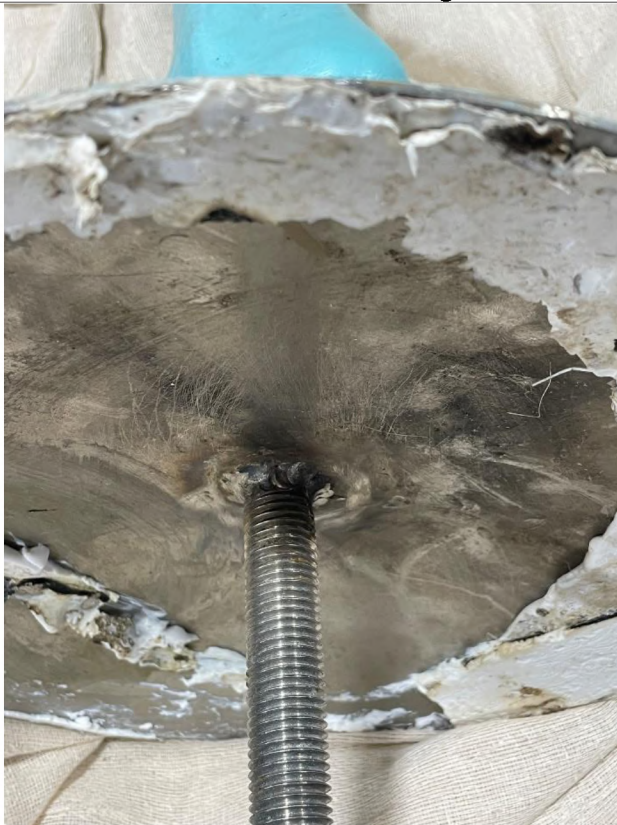
The threaded bar had been attached to a dome base plate by welding. The dome section was not available for examination on the failed part; however, this region was visible on the statue which had not failed. The comparison dome showed evidence of welds used to attach the dome base plate to the base of the statue and the threaded bar (Figure 10 & Figure 11). The weld showed a burnt appearance and was sited in a region close to where the failed material had fractured.

**Figure 10: Intact Section as-received showing threaded bar welded to the base**

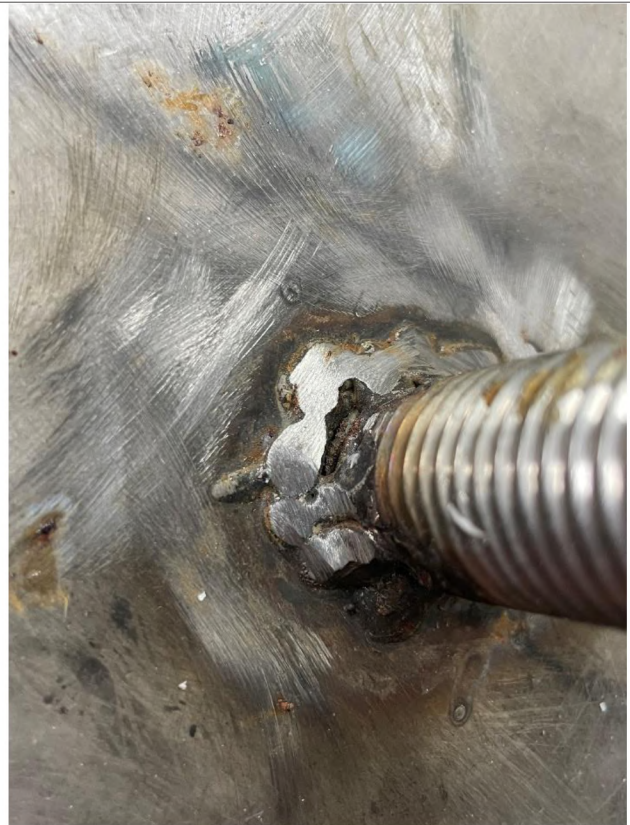
**Figure 11: Intact Section as-received showing discolouration due to heat input from welding**

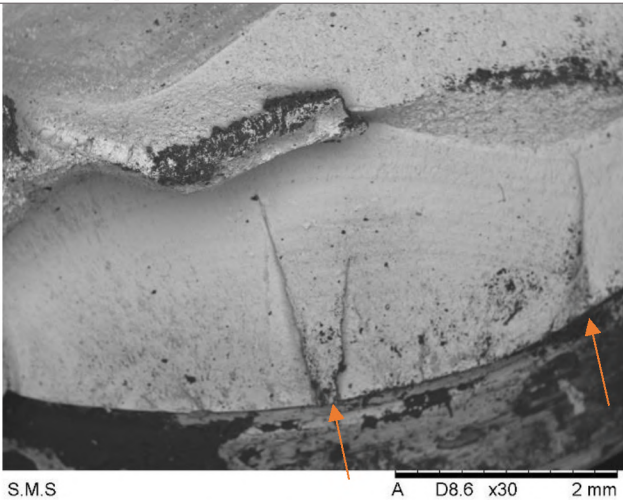
Initial low magnification showed evidence of an initiation site which propagated from the surface of the threaded bar at a thread root. There was evidence of multiple ratchet marks and beach marks indicative of a gradual fatigue mode of failure. (Figure 12& Figure 13).

Figure 12: SEM Image showing initiation from the surface at a root thread.

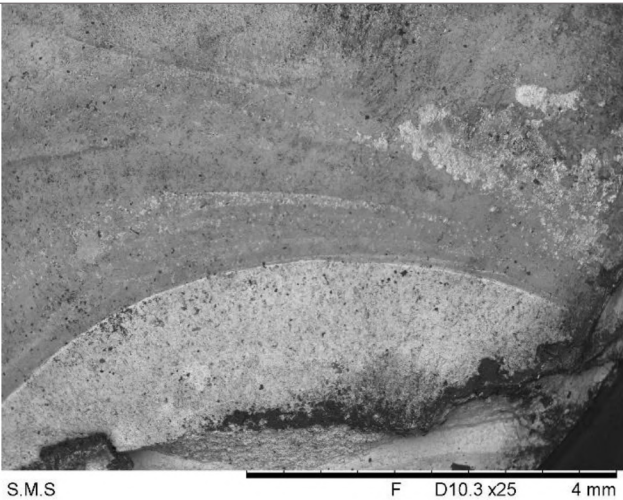
Figure 13: SEM Image showing mechanical damage / smearing and fatigue beach marks.

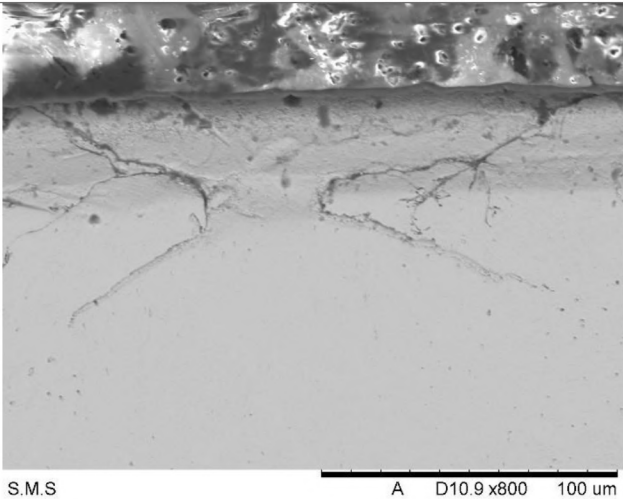
Initial low magnification revealed evidence of pre-existing material supply defects, which were consistent with a thread rolling origin. (Figure 14 to Figure 17 )

Figure 14: Surface thread rolling defects

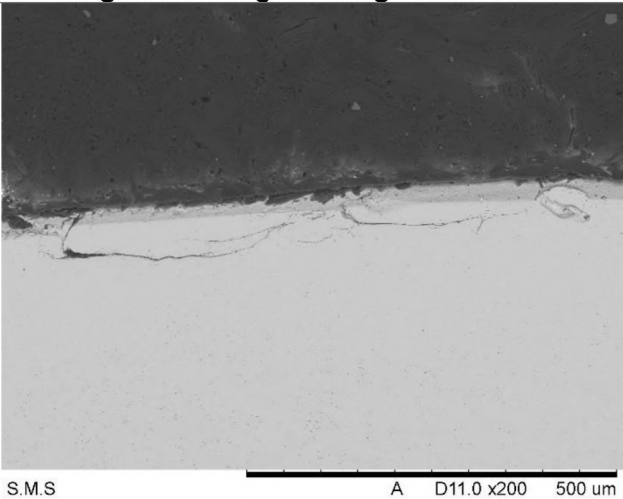
Figure 15: Surface thread rolling defects

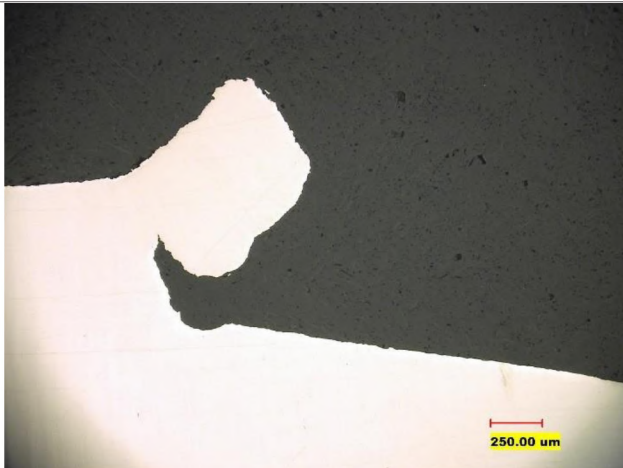
Photomicrographs failed to highlight any cracking in the bulk of the material, but did show some evidence of microcracks at the surface near the fracture face. (Figure 18 & Figure 19)

**Figure 18: Microsection taken along fracture face  
Unetched**

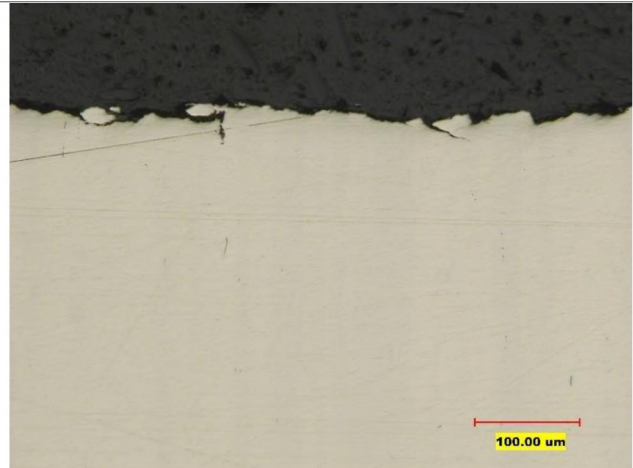
**Figure 19: Surface secondary cracking  
Unetched**

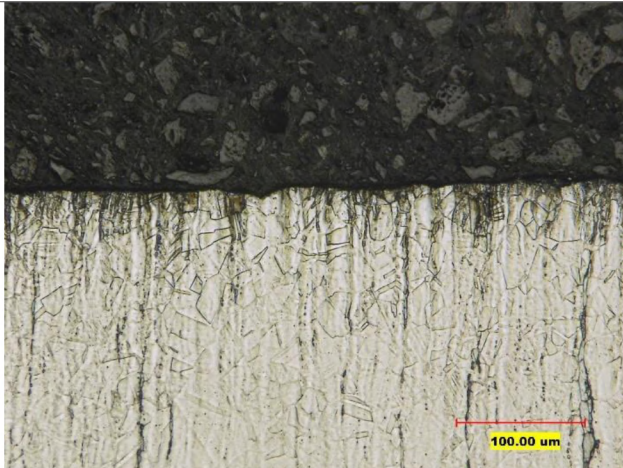
Etching the section in Kallings No2 Reagent revealed a general microstructure of twinned austenitic grains typical of a 316 stainless steel with sulphides strung out along the rolling direction. The level of sulphides observed was thought to be high for a 316 stainless grade of material. (Figure 20 & Figure 21).

**Figure 20: General microstructure  
Etchant: Kallings No 2  
Magnification: x100**

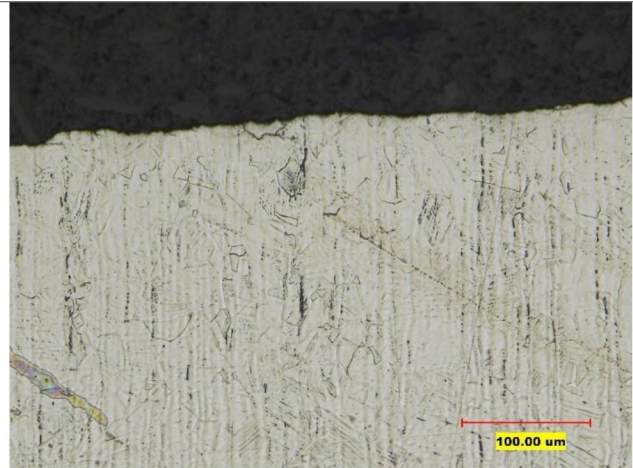
**Figure 21: Surface microstructure  
Etchant: Kallings No 2  
Magnification: x100**

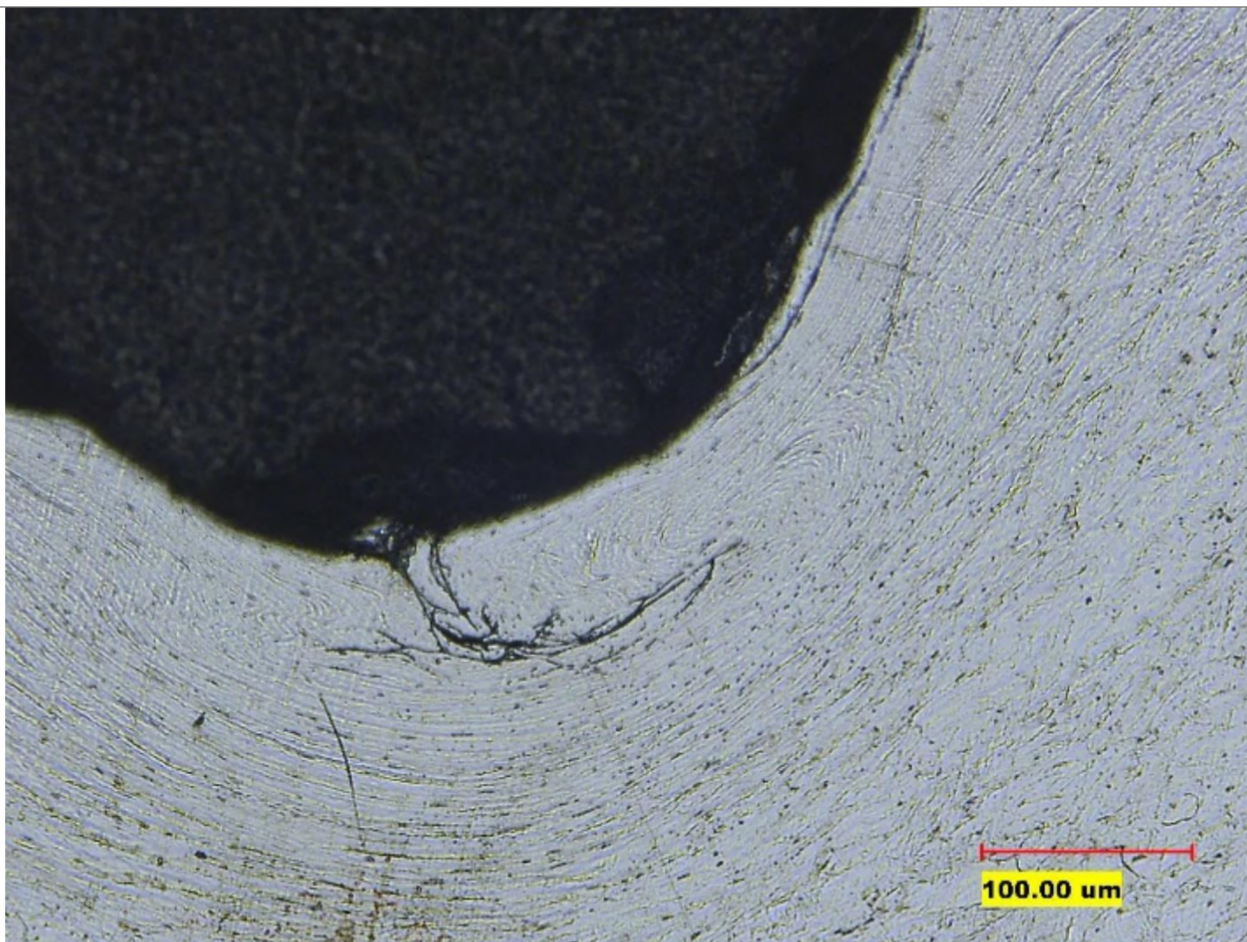
There was evidence of cracking at the thread root following the structural flow (figure 22).

**Figure 22: Microphotograph showing cracking at the thread root following the structural flow.  
Etchant: Kallings No 2  
Magnification: x500**

Sectioning of the threaded bar revealed a presence of manufacturing defects, which followed the structural flow lines in the rolling direction.

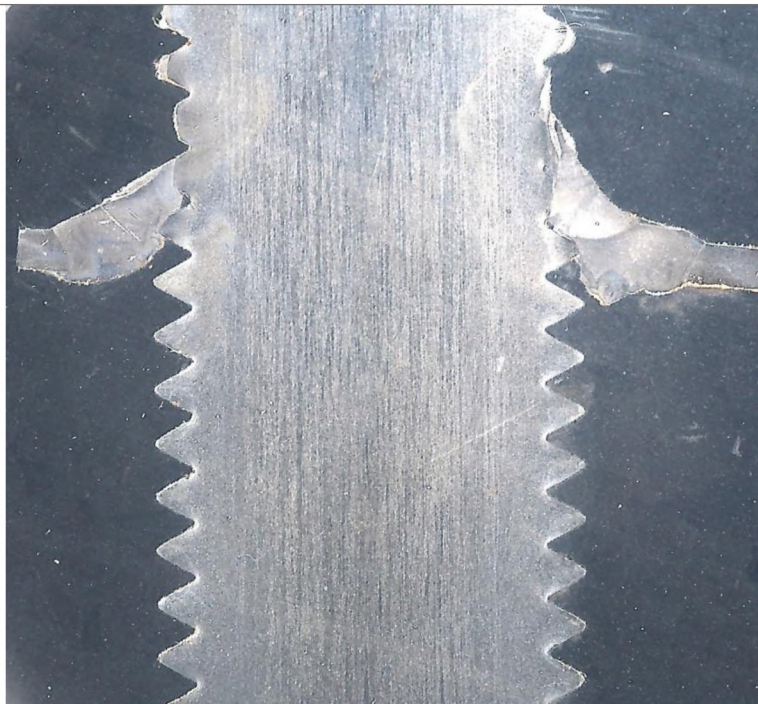
Sectioning through the dome welded region in a longitudinal orientation revealed that the welding process had caused a large heat affected zone (HAZ) extending approximately 1.05mm into the base threaded bar (Figure 23). Cracking was observed in the root of the weld (Figure 24). There was no evidence of cracking extending into the bulk material from the weld. The change in the microstructure at the HAZ (Figure 25) would alter the mechanical properties of the bar and lead to structural weakness in this area. Some of the threads were also not present due to melting. There was evidence of cracking sited in the root of the threads, following the structural flow (Figure 26).

**Figure 23: Section through welded region showing large heat affected zone (HAZ) and destruction of threads due to weld heat input**

The intact threaded bar showed a reduction in hardness at the HAZ near where the bar was welded to the dome. The lower hardness due to heat input will have reduced the structural capability of the bar.

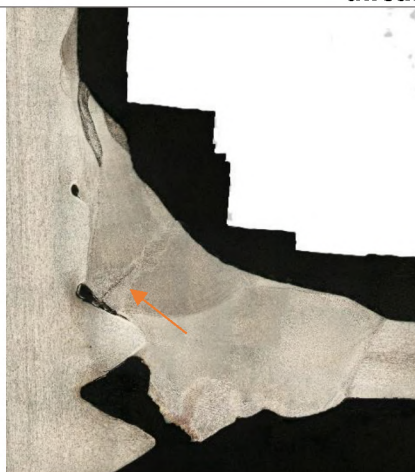
**Figure 24: Microphotograph showing weld root crack.  
Etchant: Kallings No 2  
Magnification: x100**

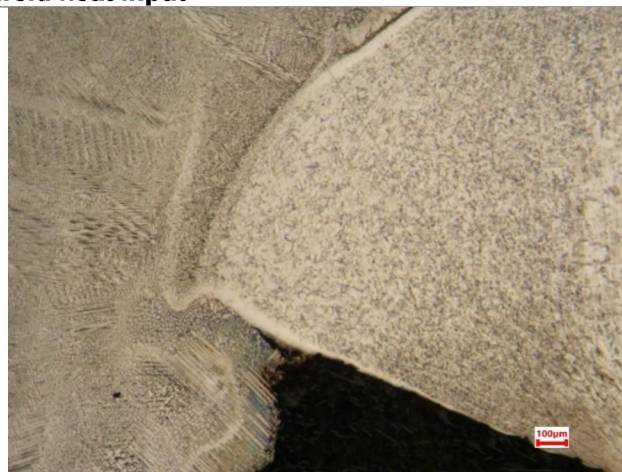
**Figure 25: Microphotograph showing weld onto threads and change in microstructure at HAZ.  
Etchant: Kallings No 2  
Magnification: x100**

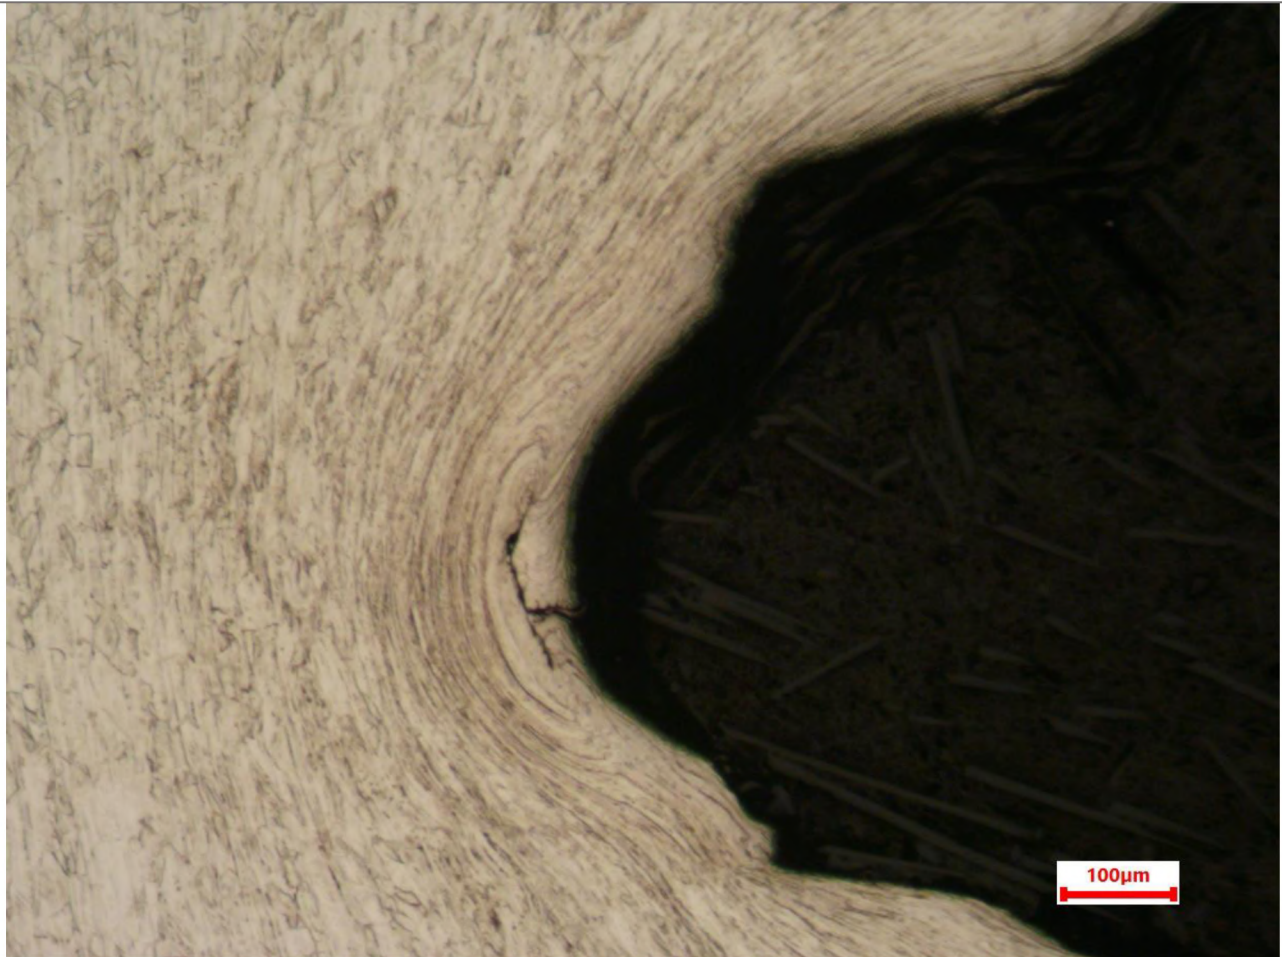
**Figure 26: Microphotograph showing cracking at the thread root following the structural flow.  
Etchant: Kallings No 2  
Magnification: x100**
